# CAPITAL PROJECTS ALL SCHOOLS

# » DISTRICT-WIDE CAPITAL PROJECTS

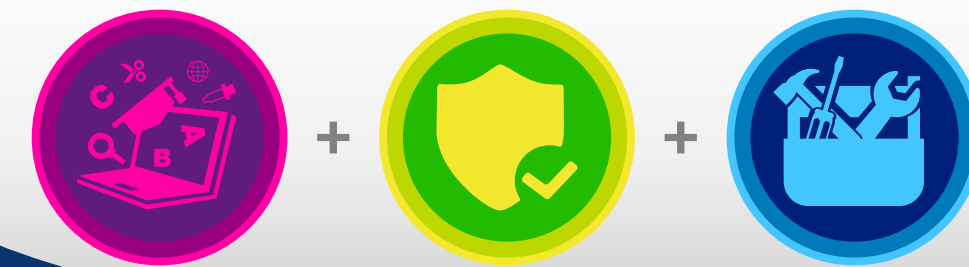
# » DISTRICT-WIDE CAPITAL PROJECTS

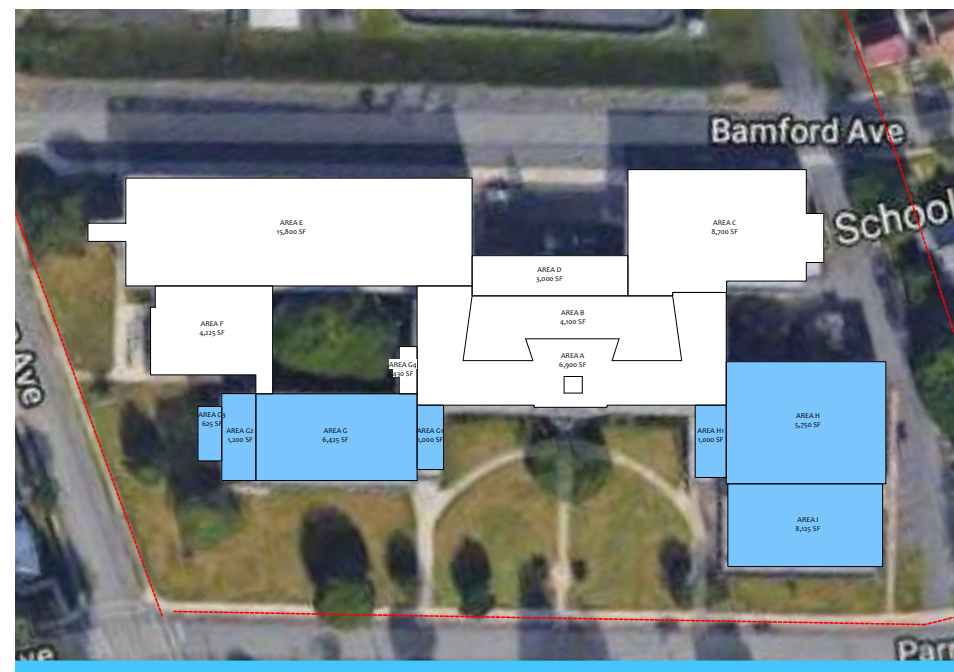
**HAWTHORNE H.S.**  
 ■ Remove & Replace  
 +/- 24,000 SF  
 of Roofing Systems

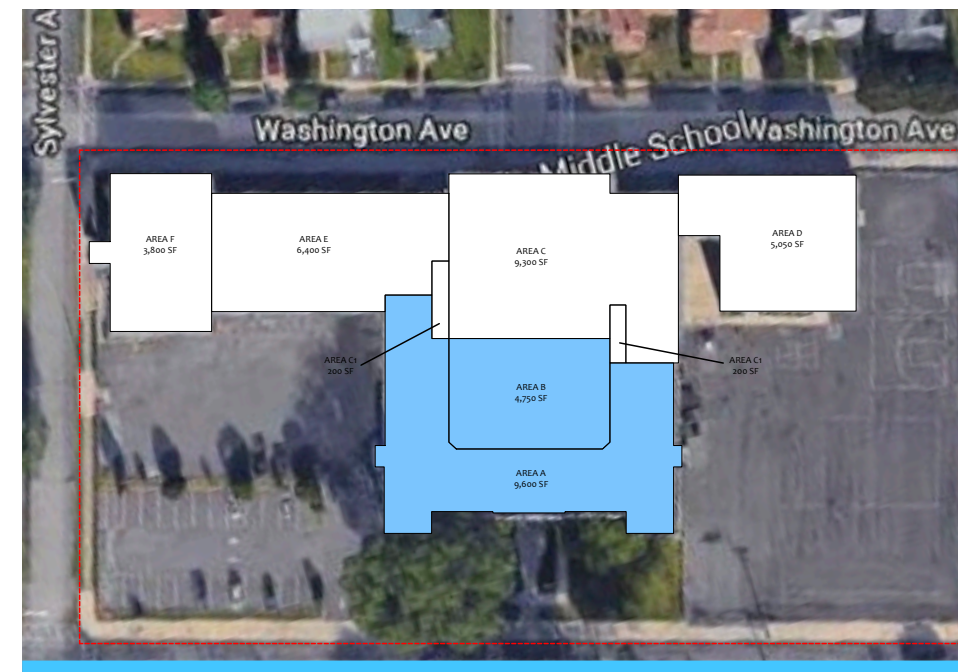
**LINCOLN M.S.**  
 ■ Remove & Replace  
 +/- 15,000 SF  
 of Roofing Systems

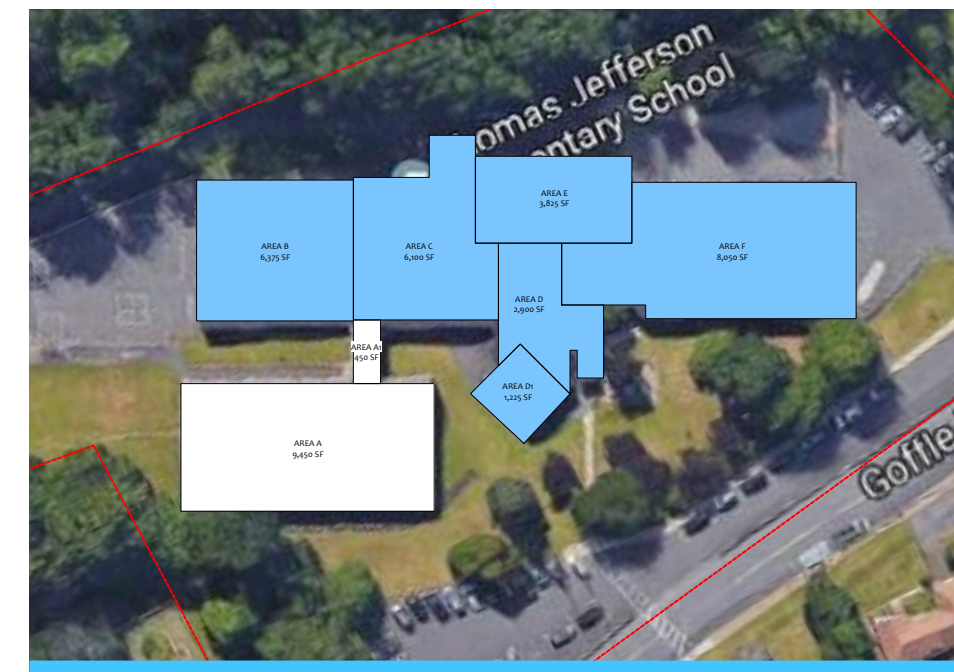
**JEFFERSON E.S.**  
 ■ Remove & Replace  
 +/- 30,000 SF  
 of Roofing Systems

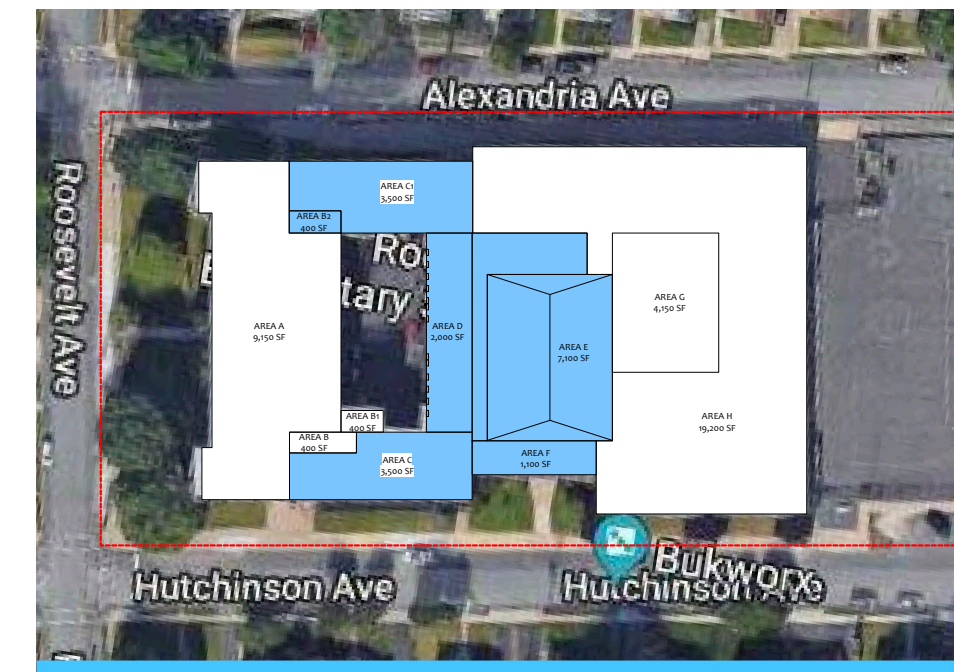
**ROOSEVELT E.S.**  
 ■ Remove & Replace  
 +/- 17,600 SF  
 of Roofing Systems

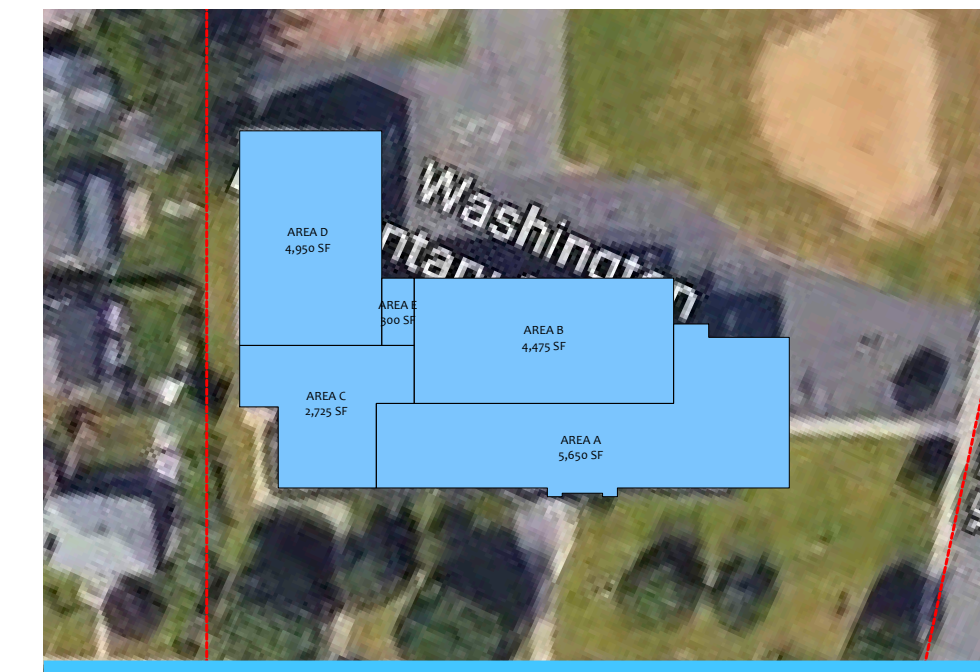
**WASHINGTON E.S.**  
 ■ Remove & Replace  
 +/- 18,000 SF  
 of Roofing Systems

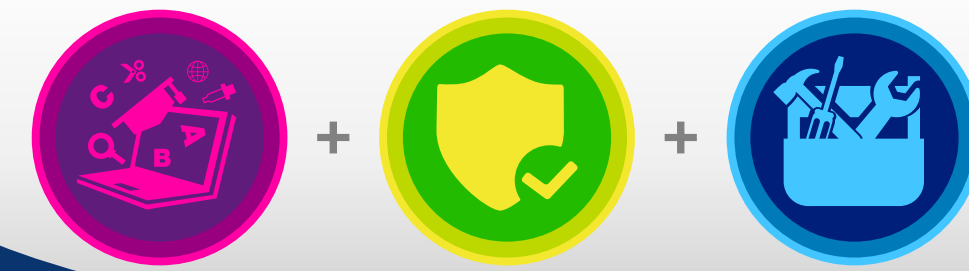
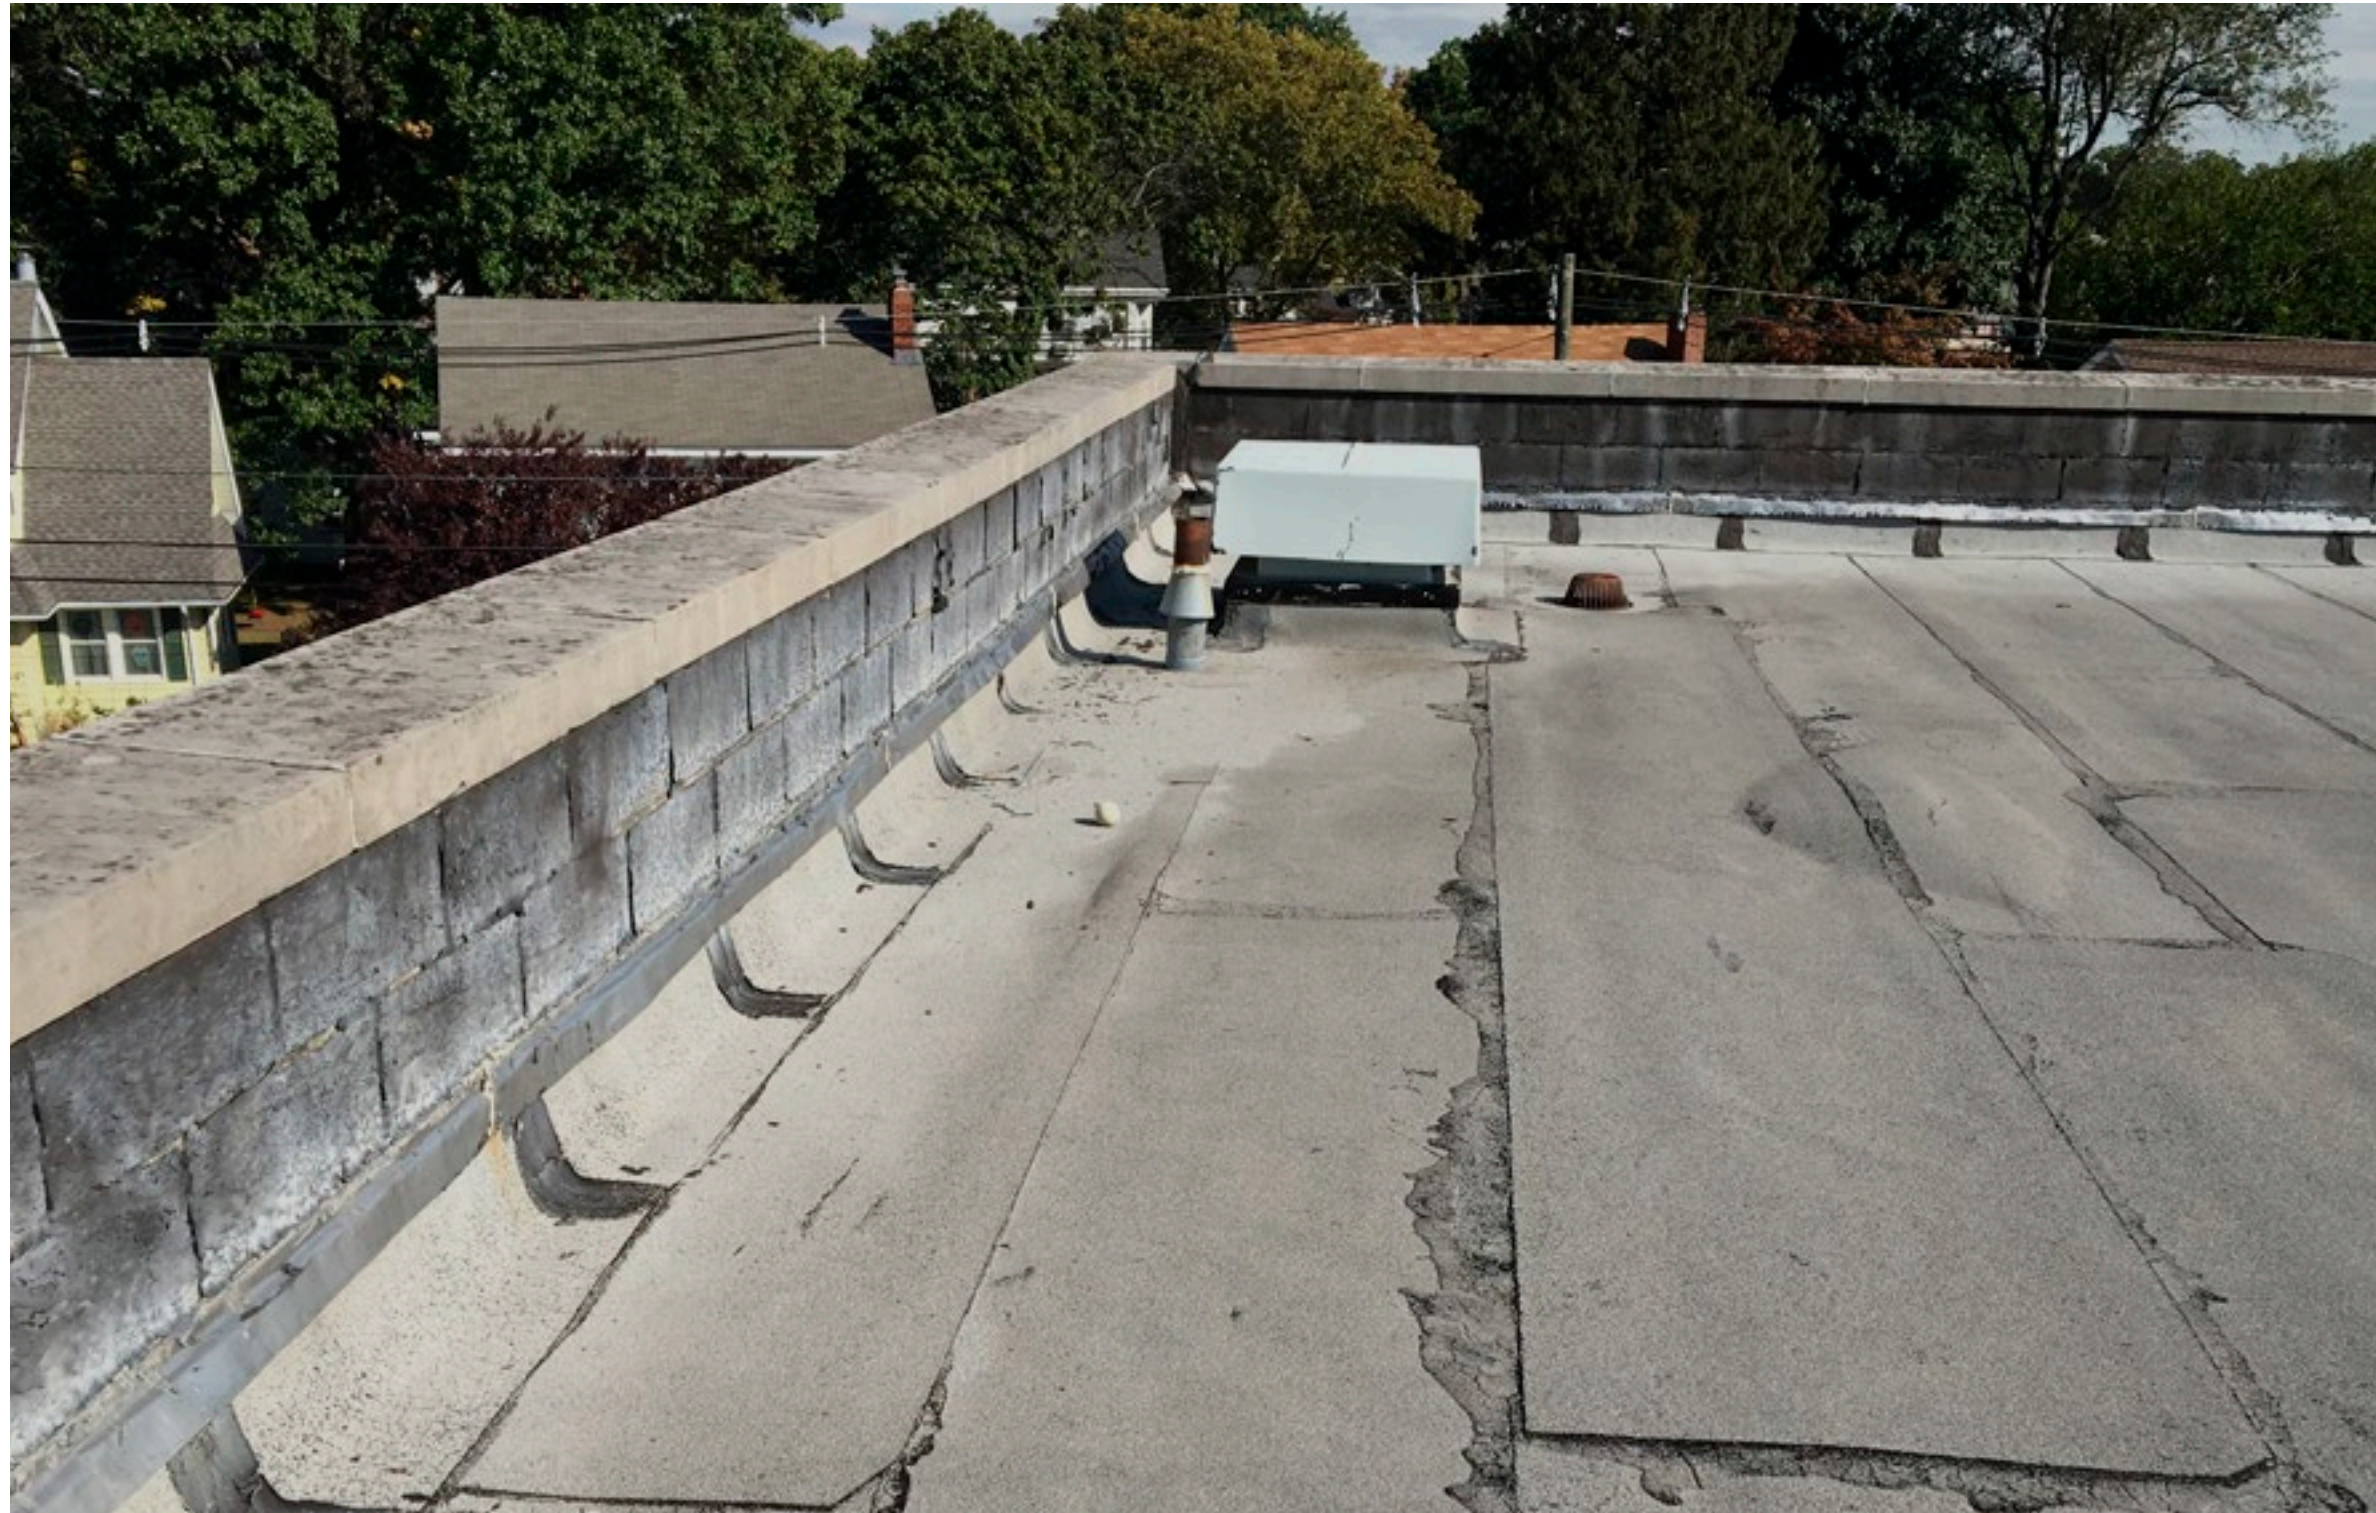
**DETERIORATED ROOF SECTION - VISIBLE AIR BLISTERS, POOR FLASHING AND COPING**

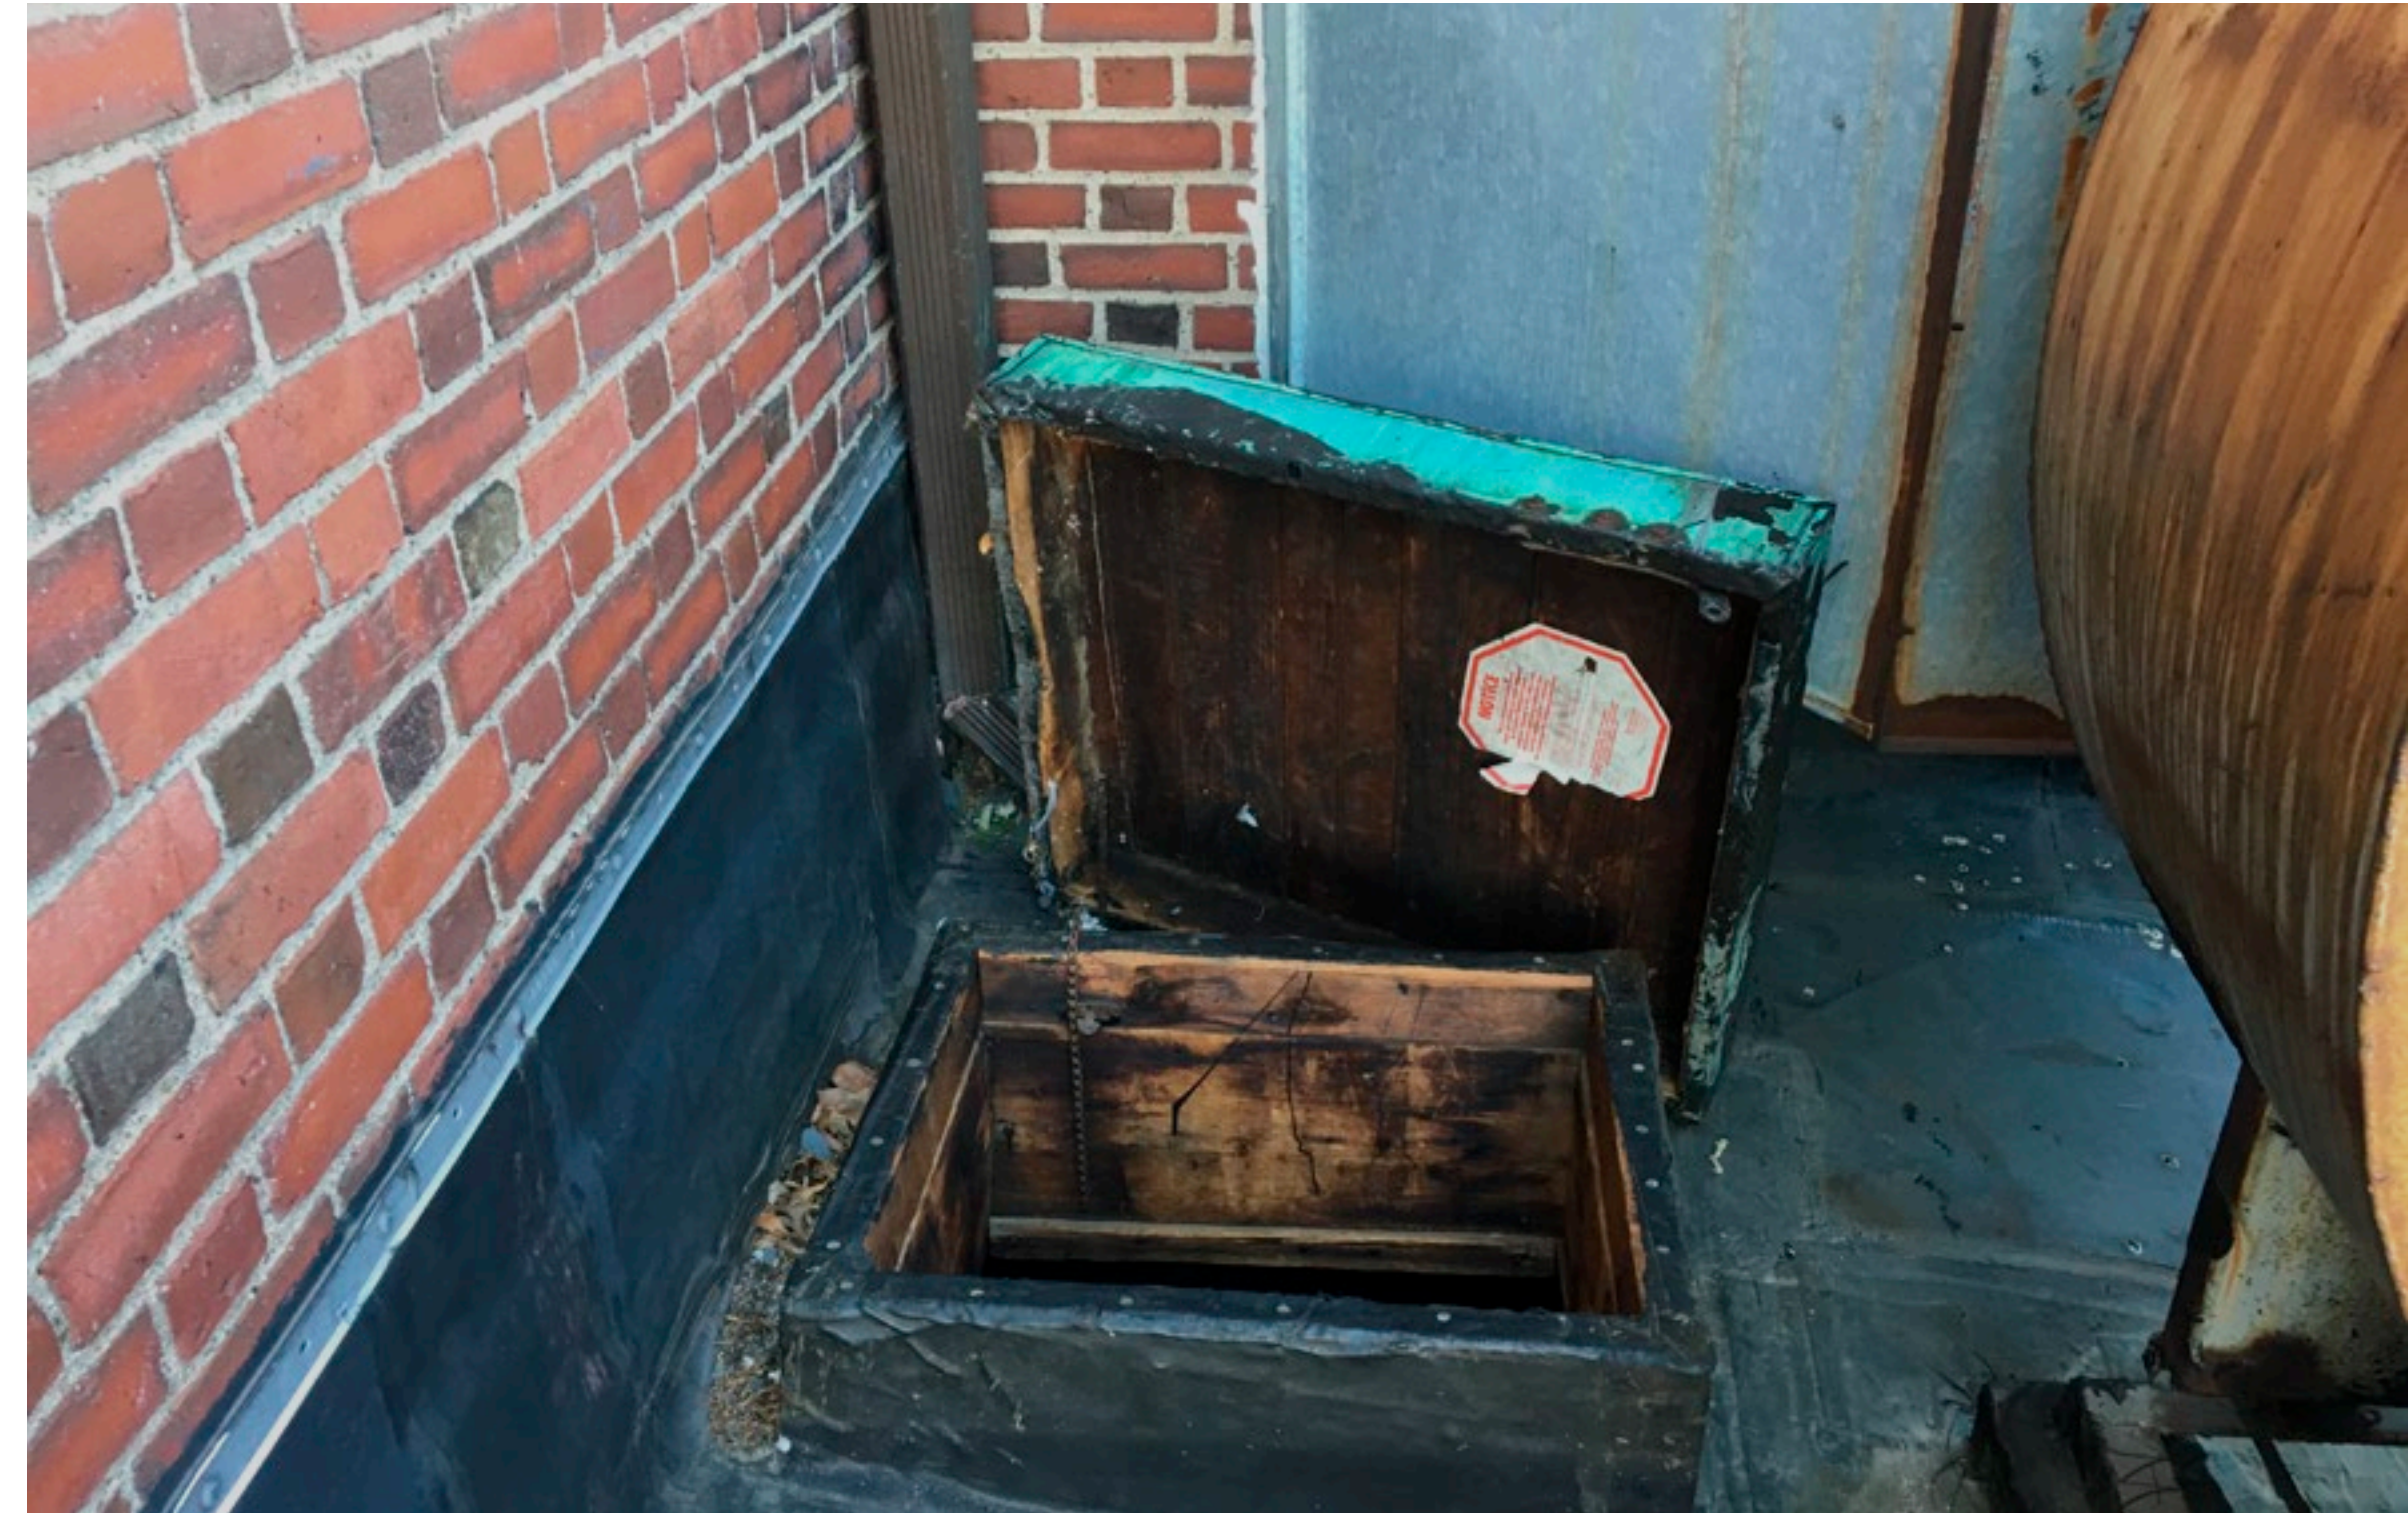
**NON-SECURE ROOF ACCESS HATCH**

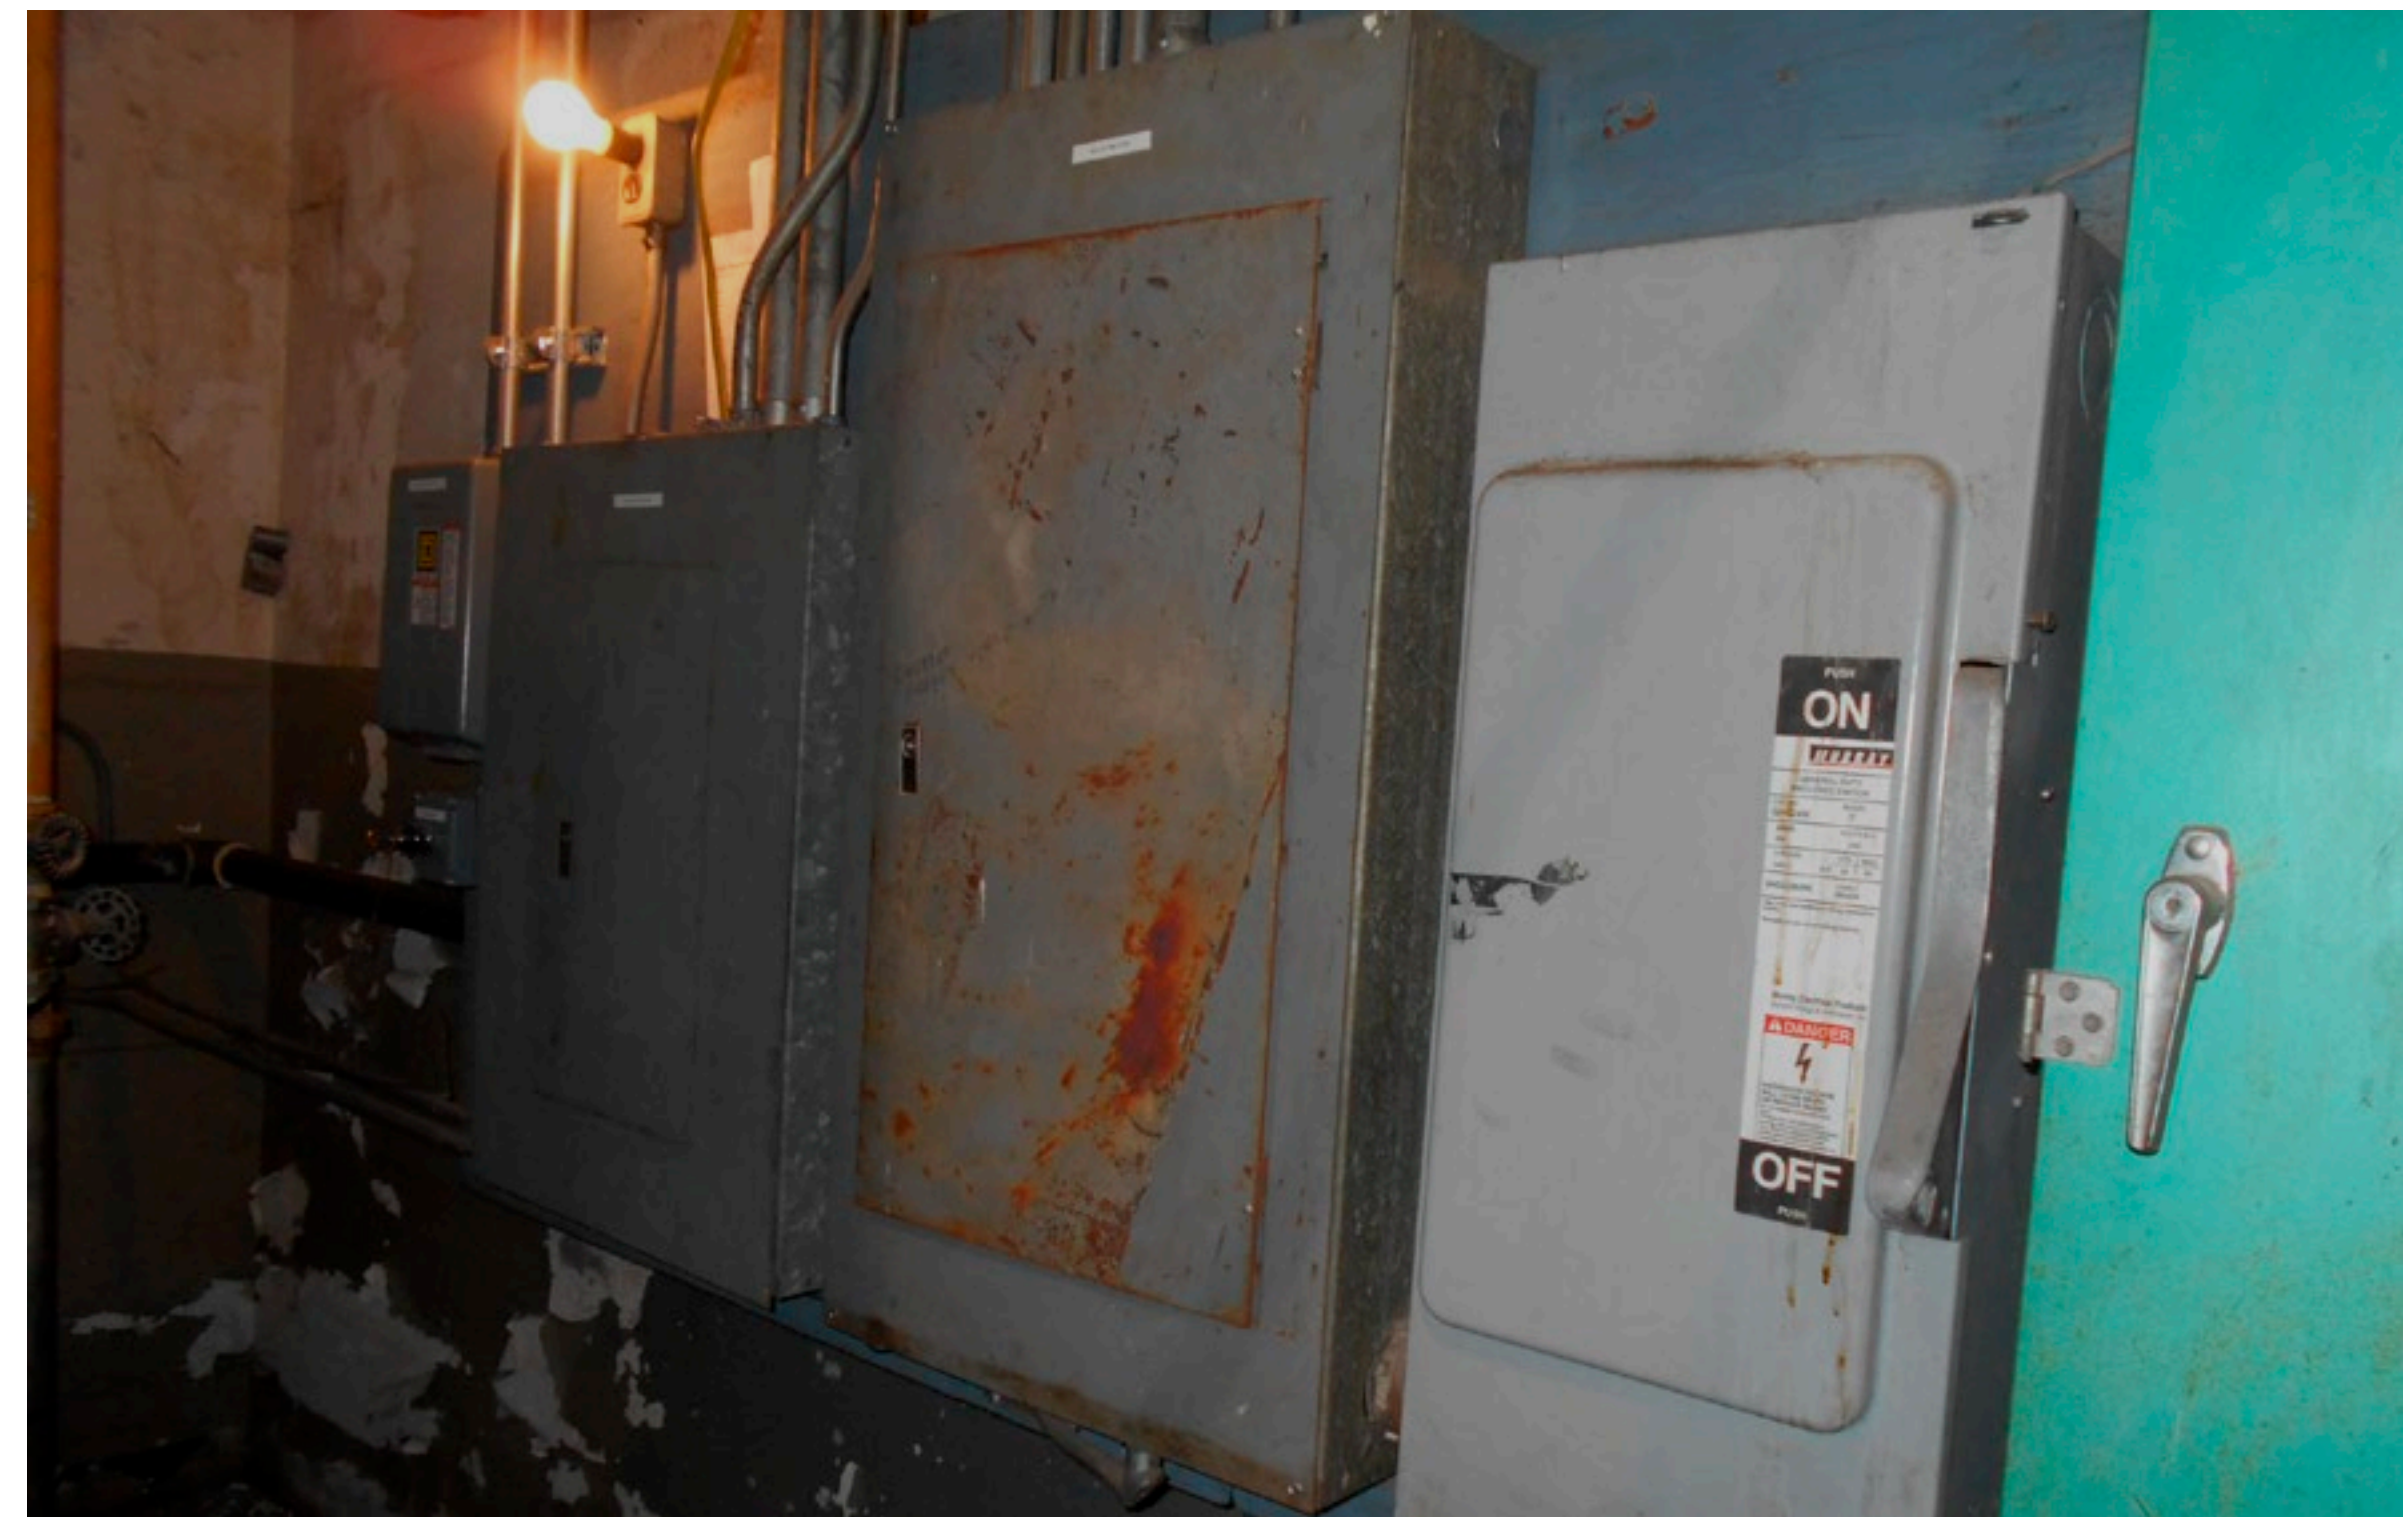
**RUSTED ELECTRICAL PANELS**

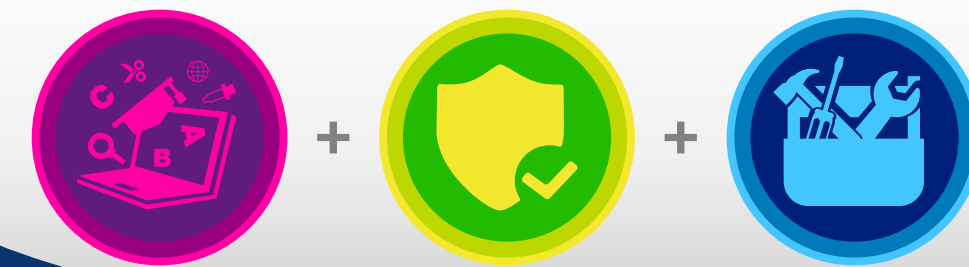
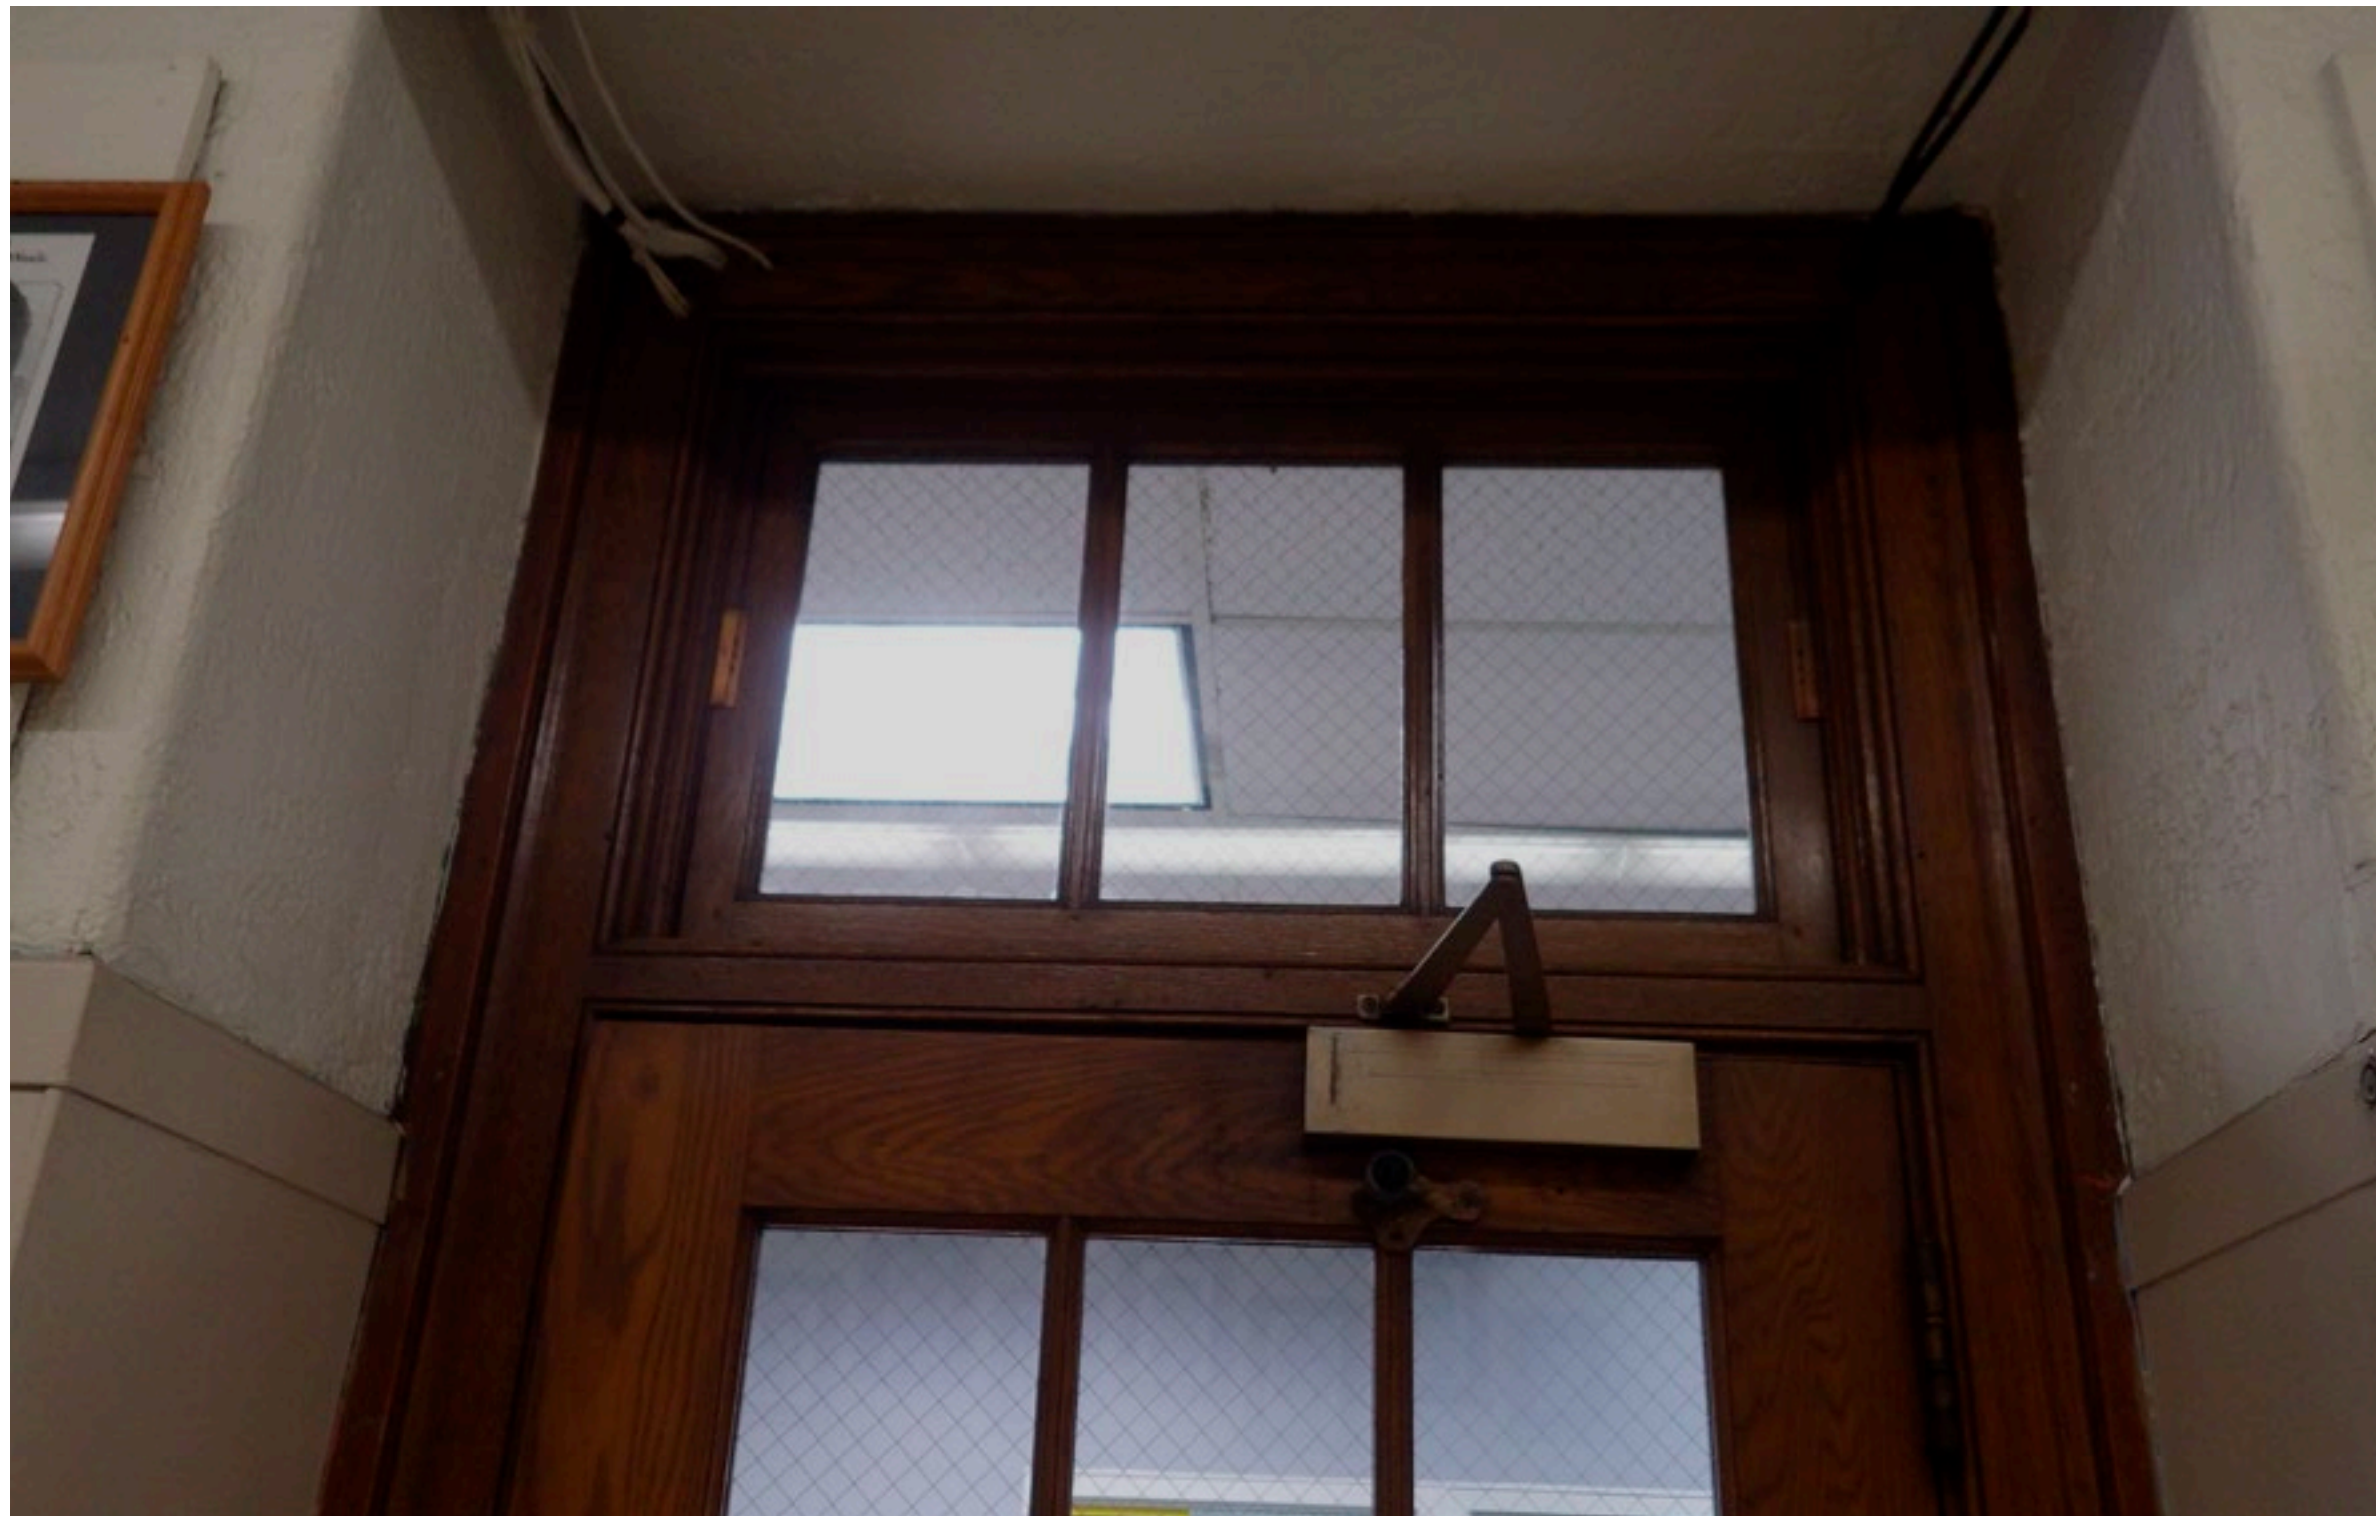
**GLASS ON DOOR CANNOT BE SECURED DURING LOCKDOWN; DOORS DO NOT MEET CURRENT CODE**

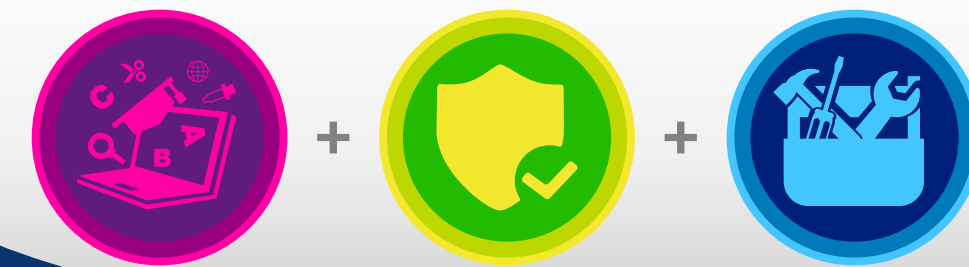
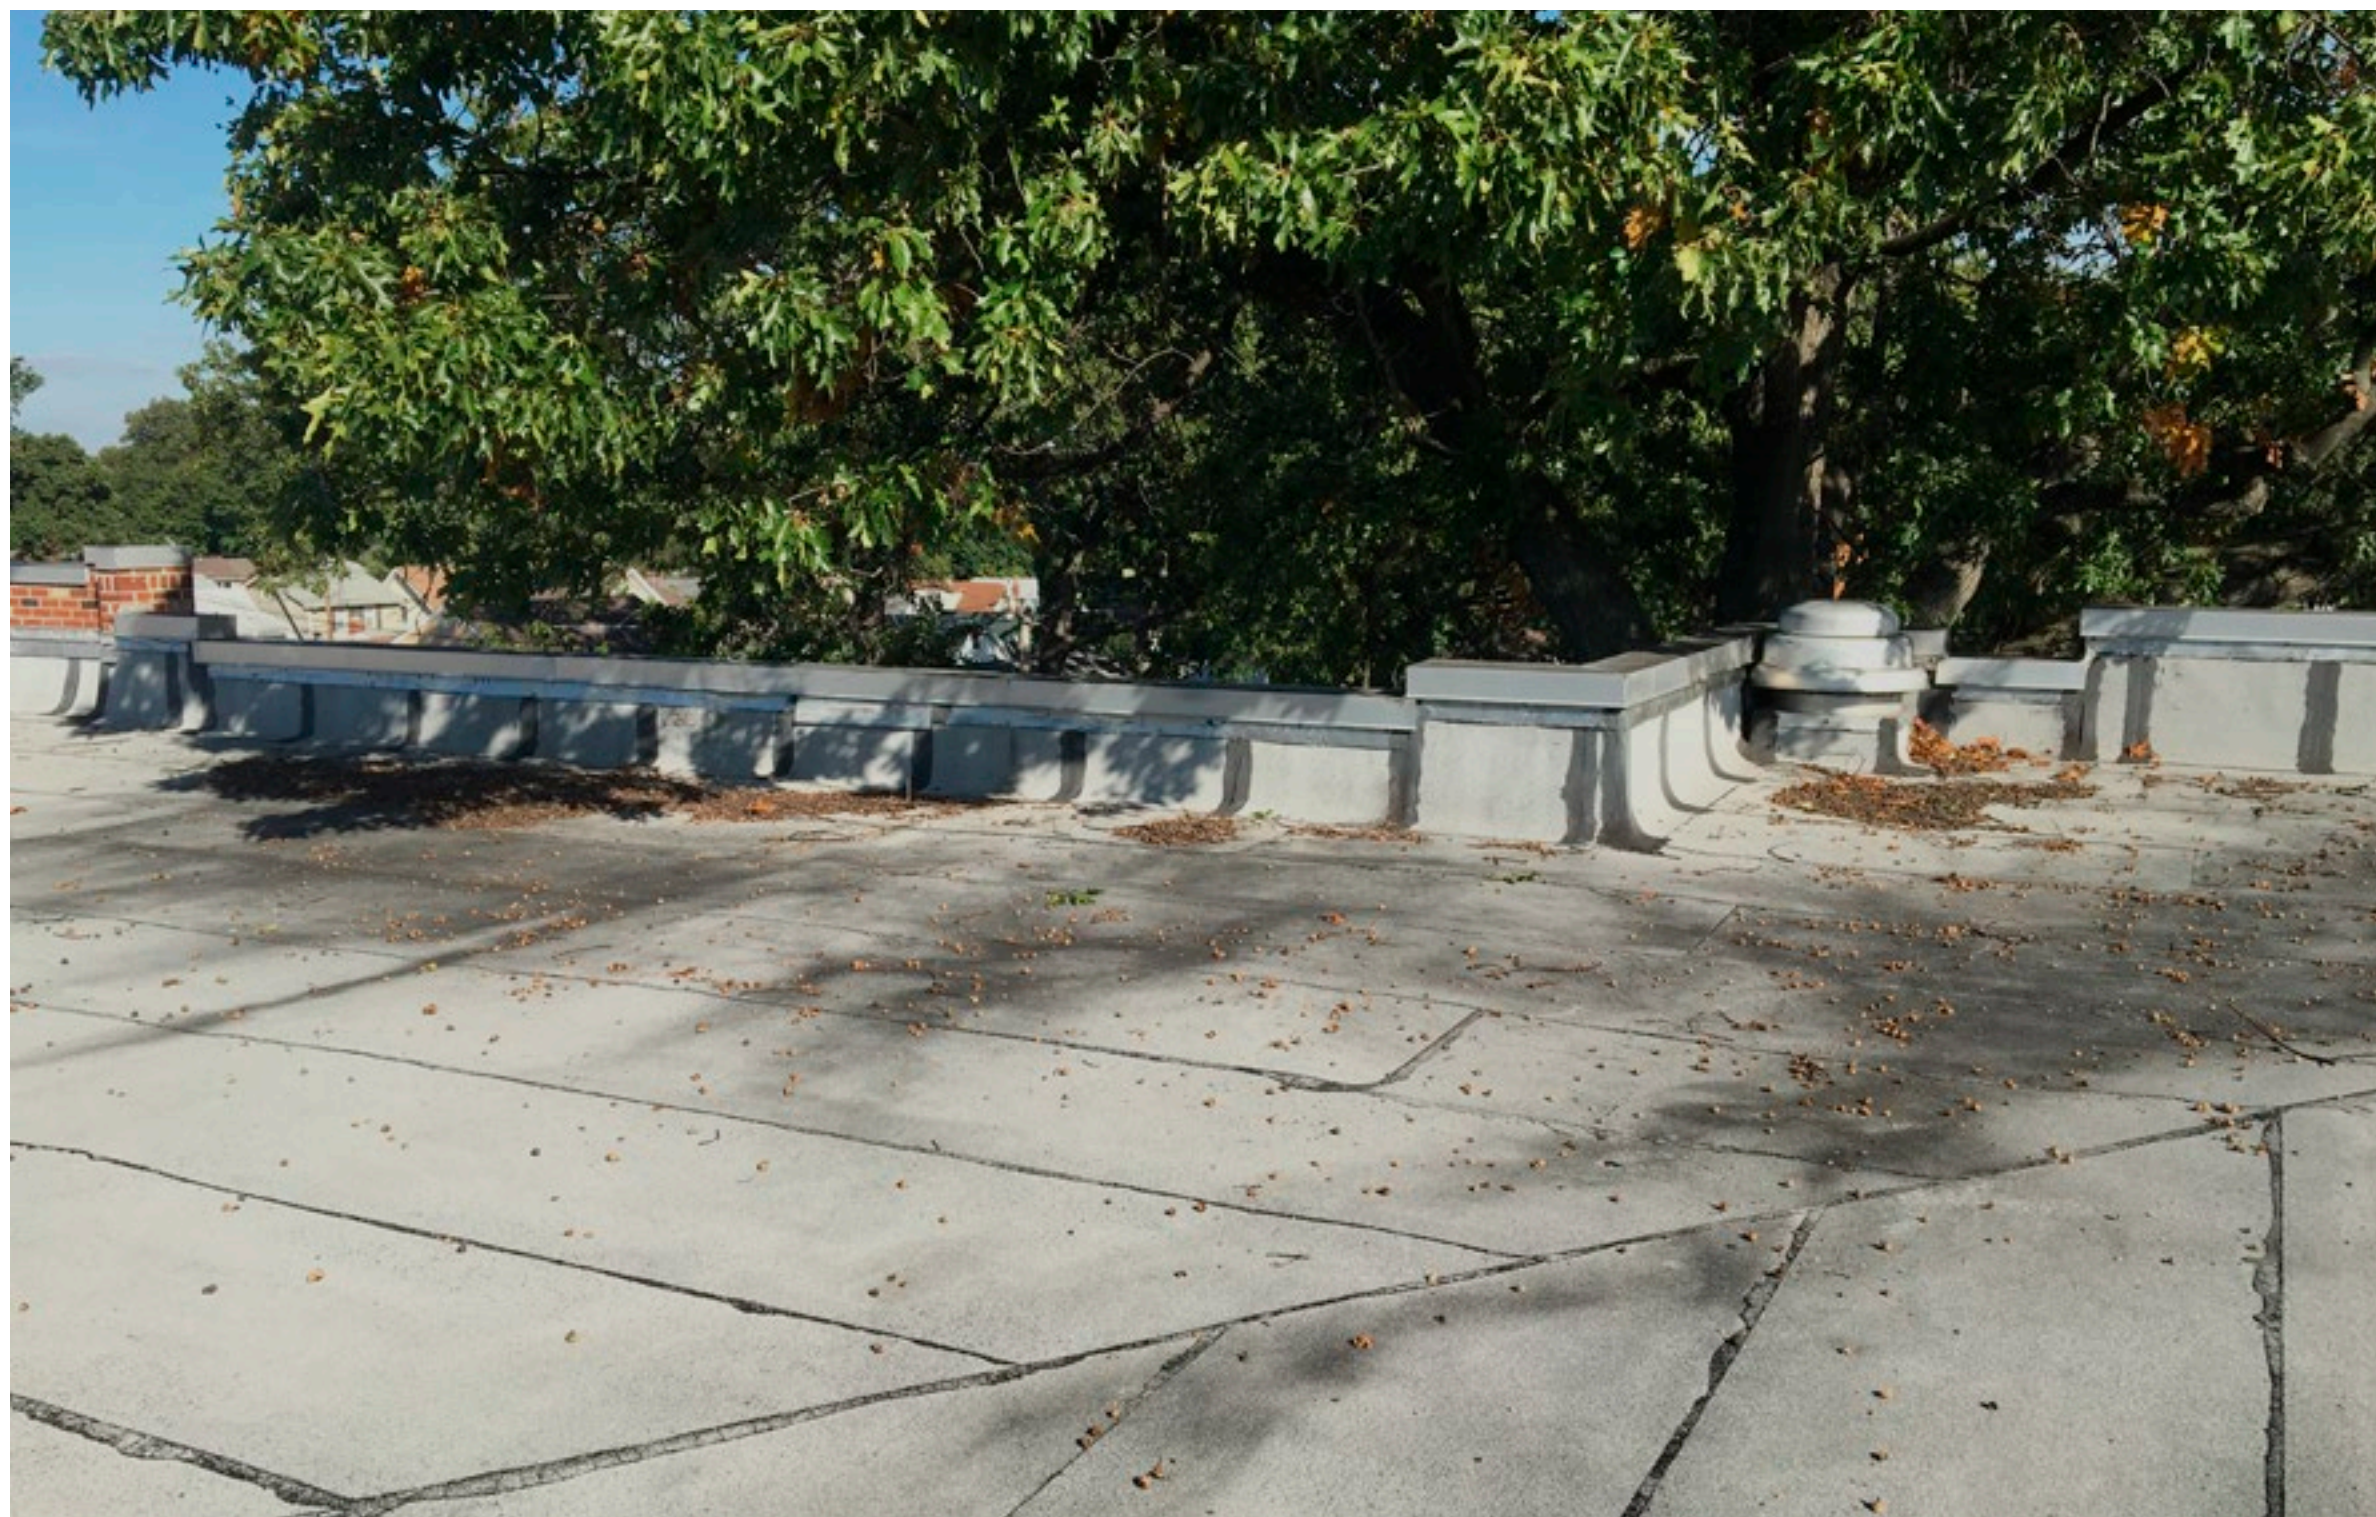
**DETERIORATED ROOF SECTION -  
DARK AREAS INDICATE STANDING WATER**
