# CAPITAL PROJECTS ALL SCHOOLS

# » DISTRICT-WIDE CAPITAL PROJECTS

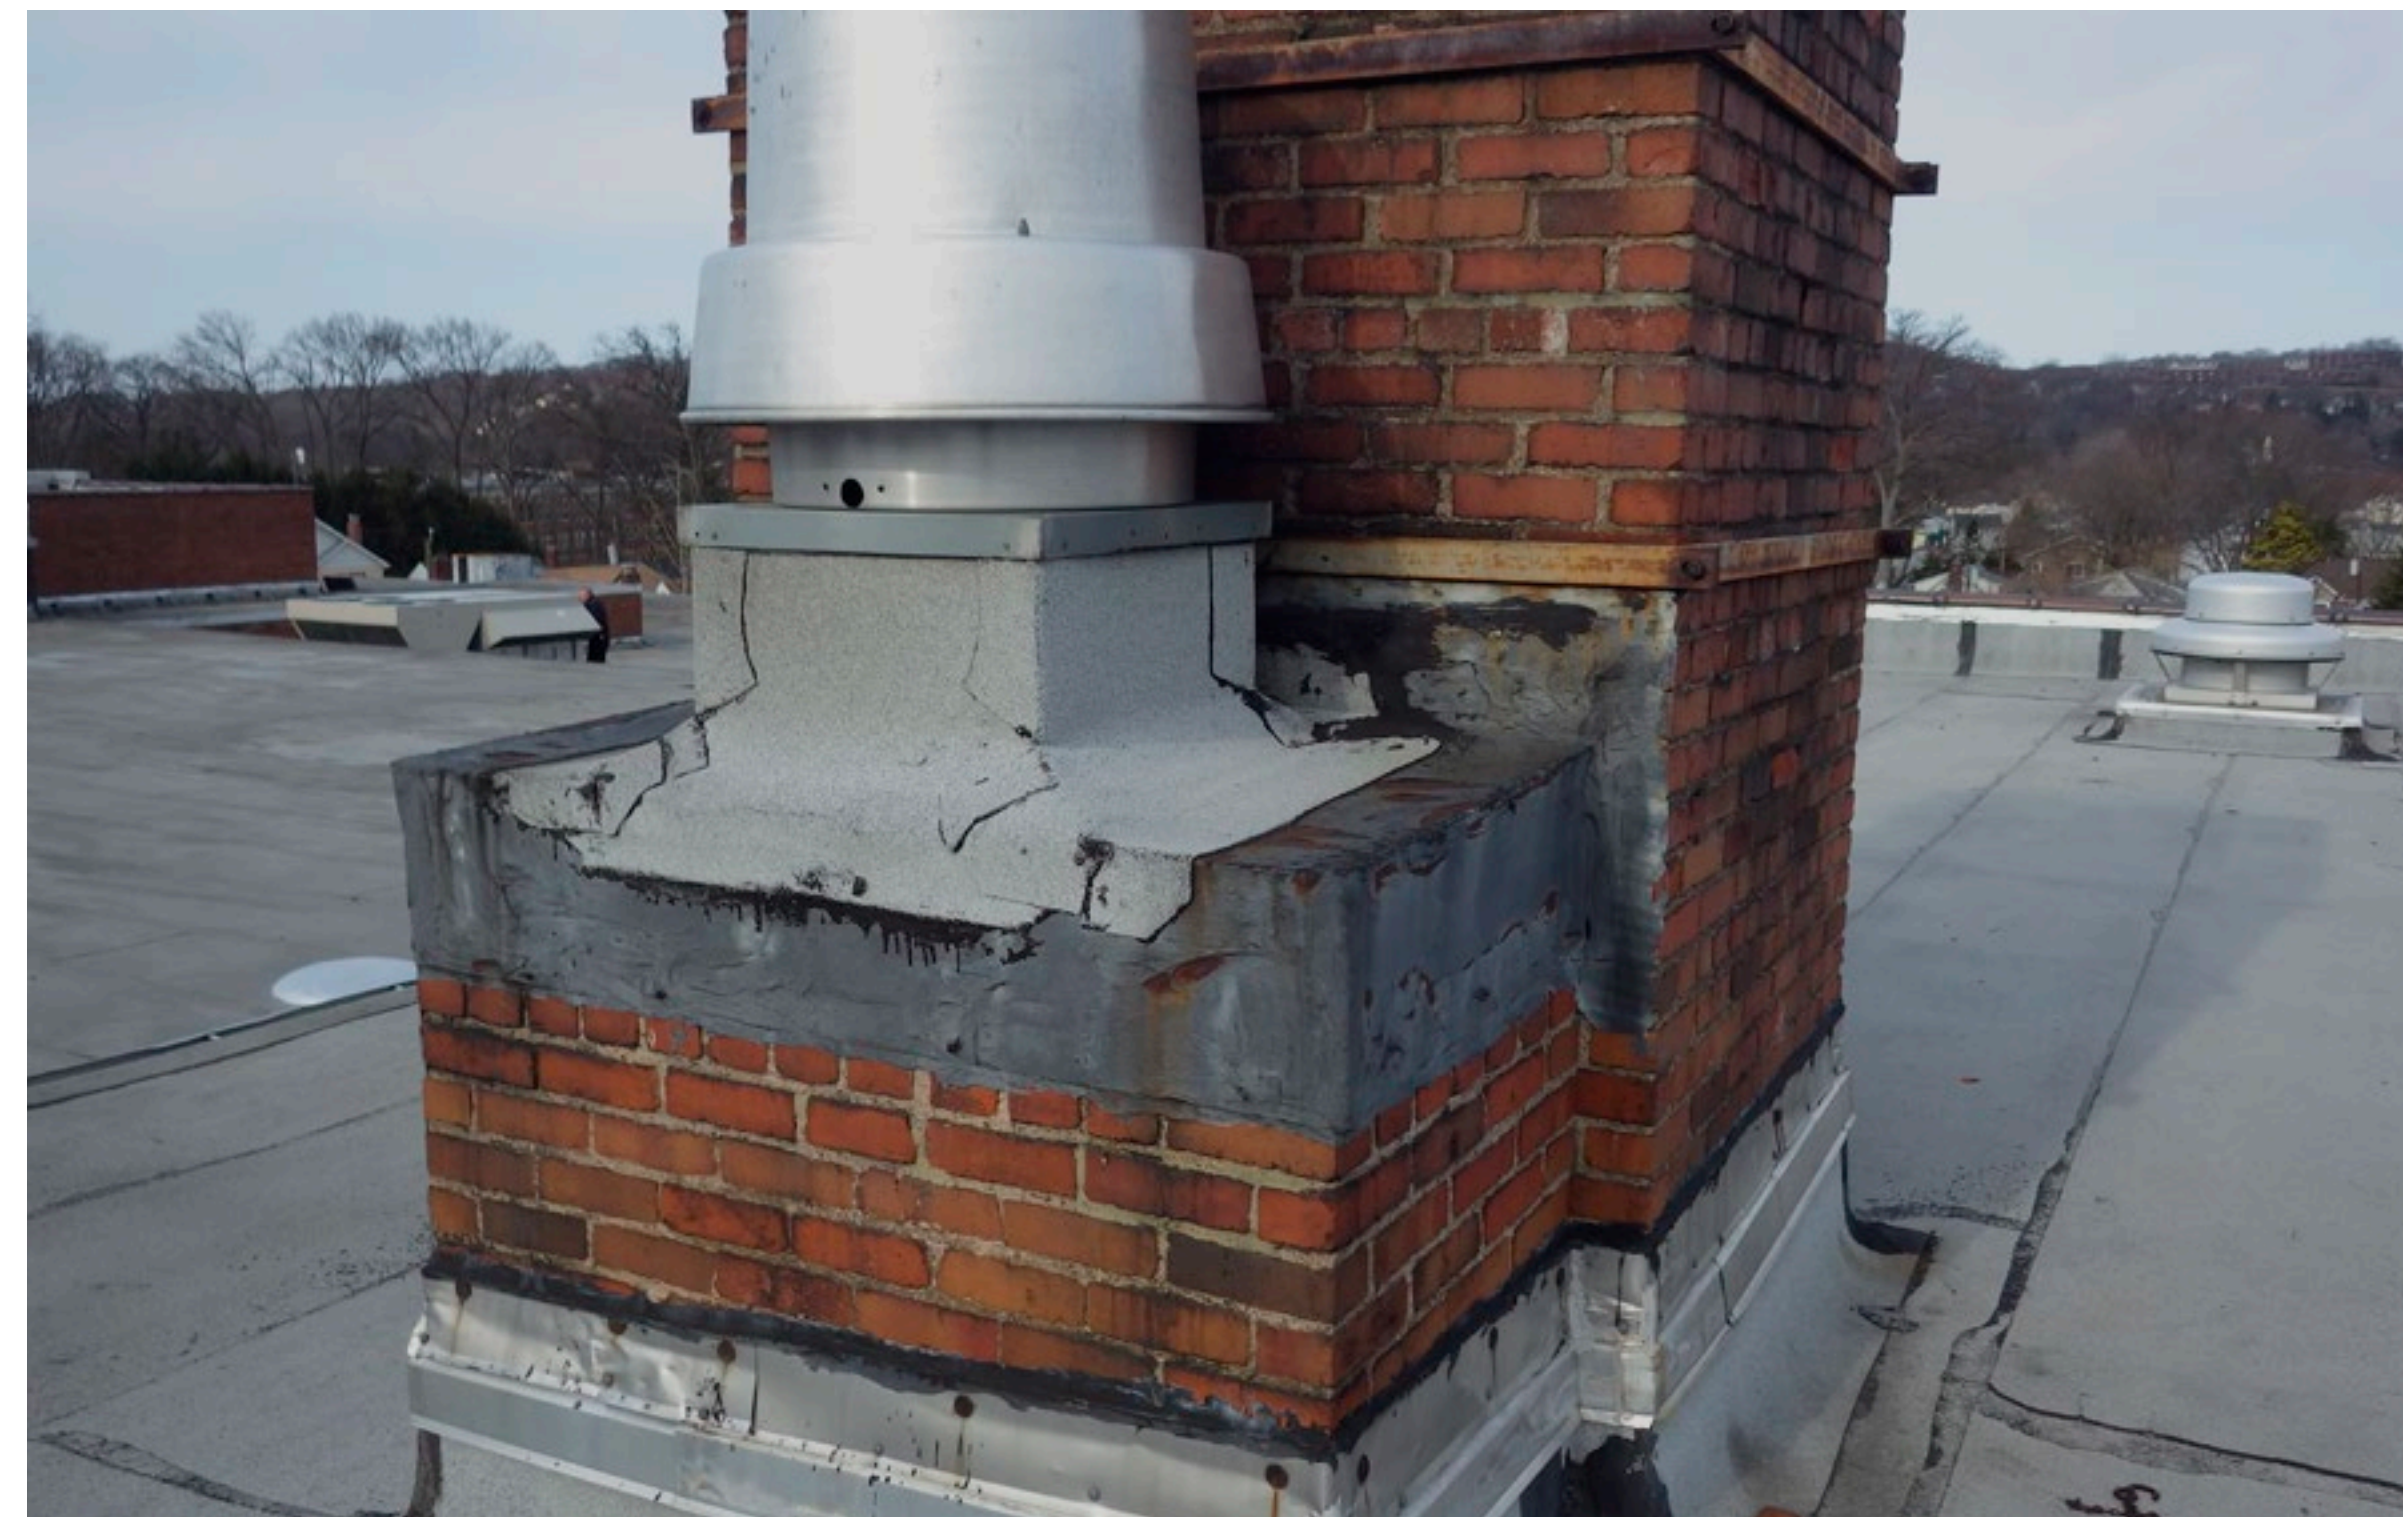
**CHIMNEY FLASHING IN POOR CONDITION**

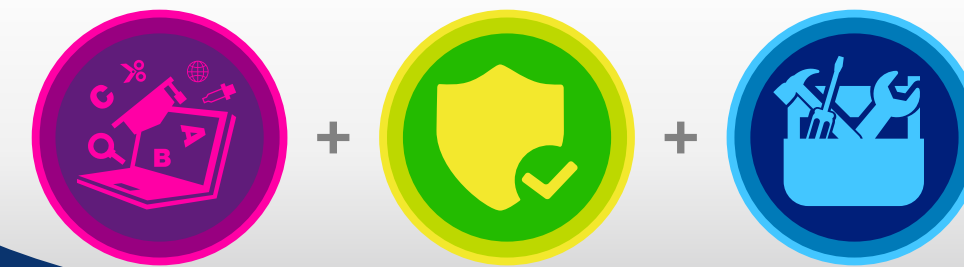
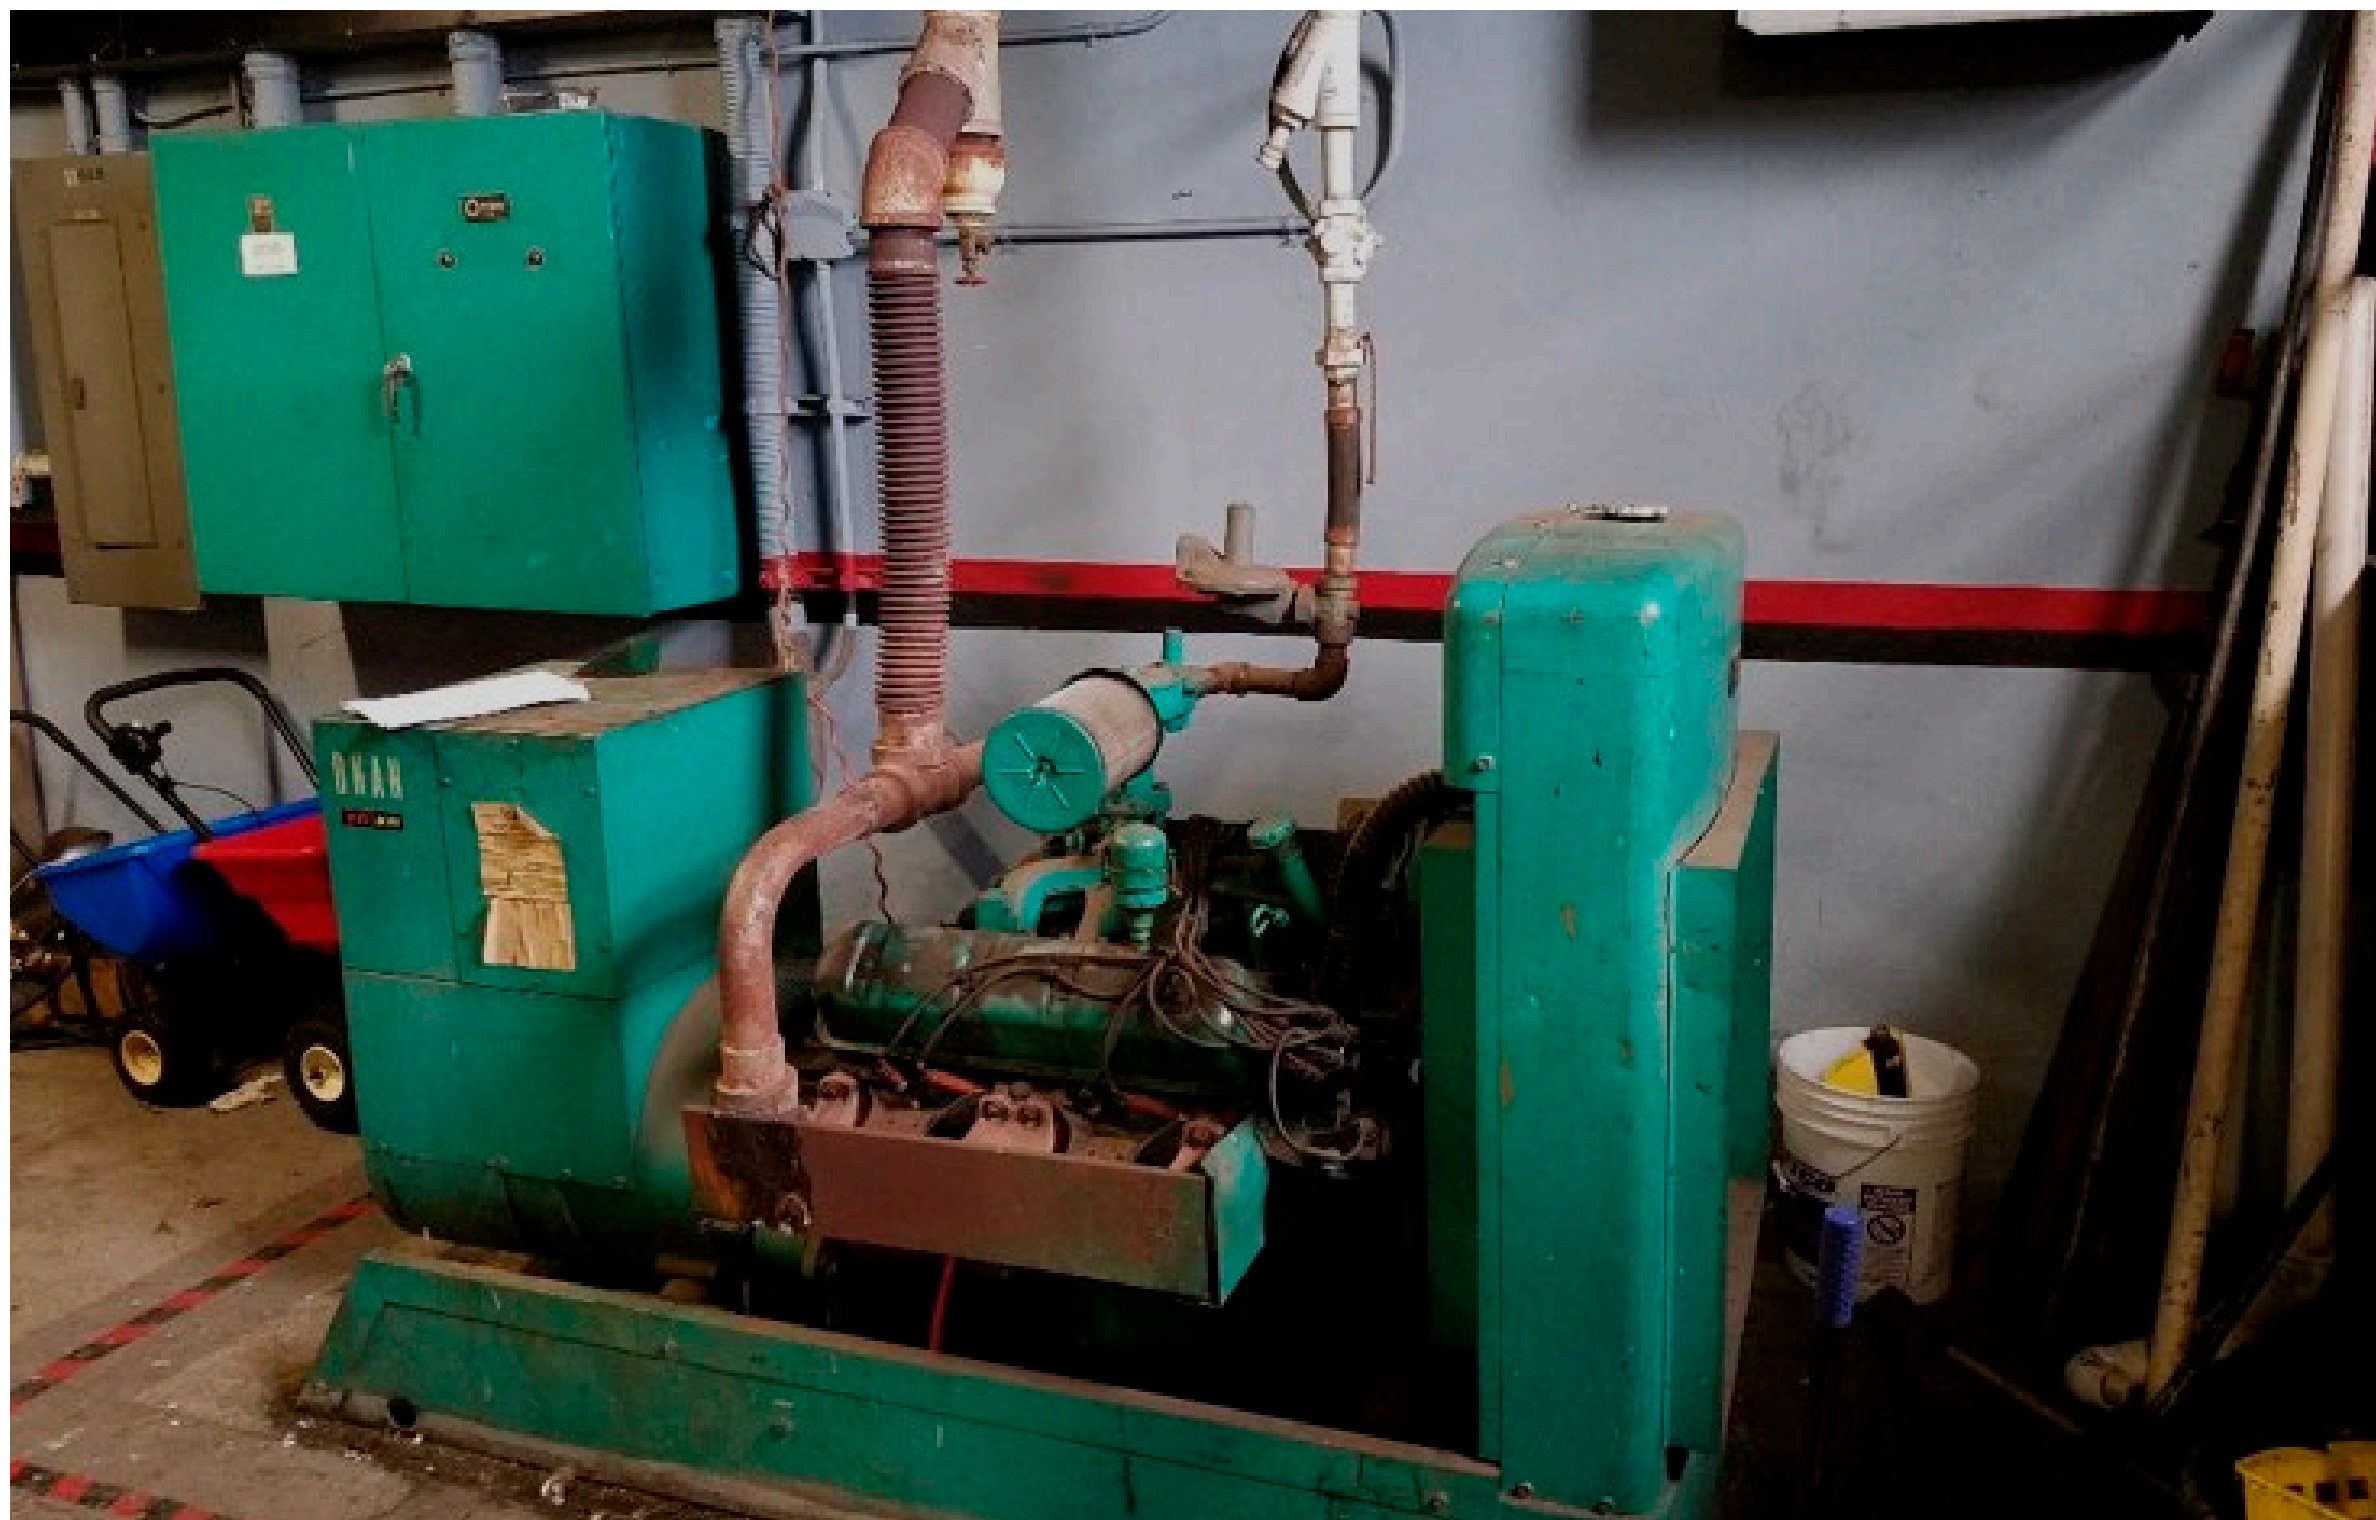
**EXISTING GENERATOR IS WELL BEYOND IT'S LIFE EXPECTANCY**

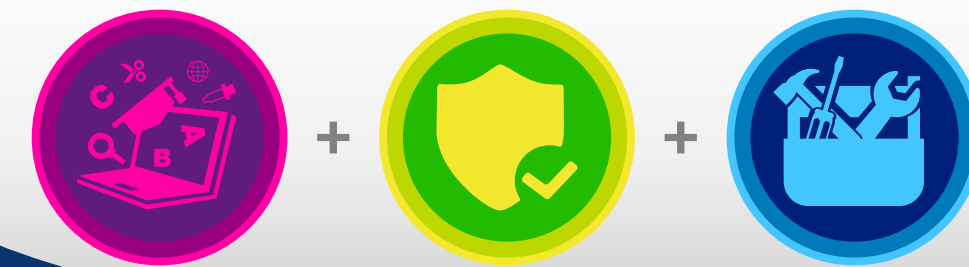
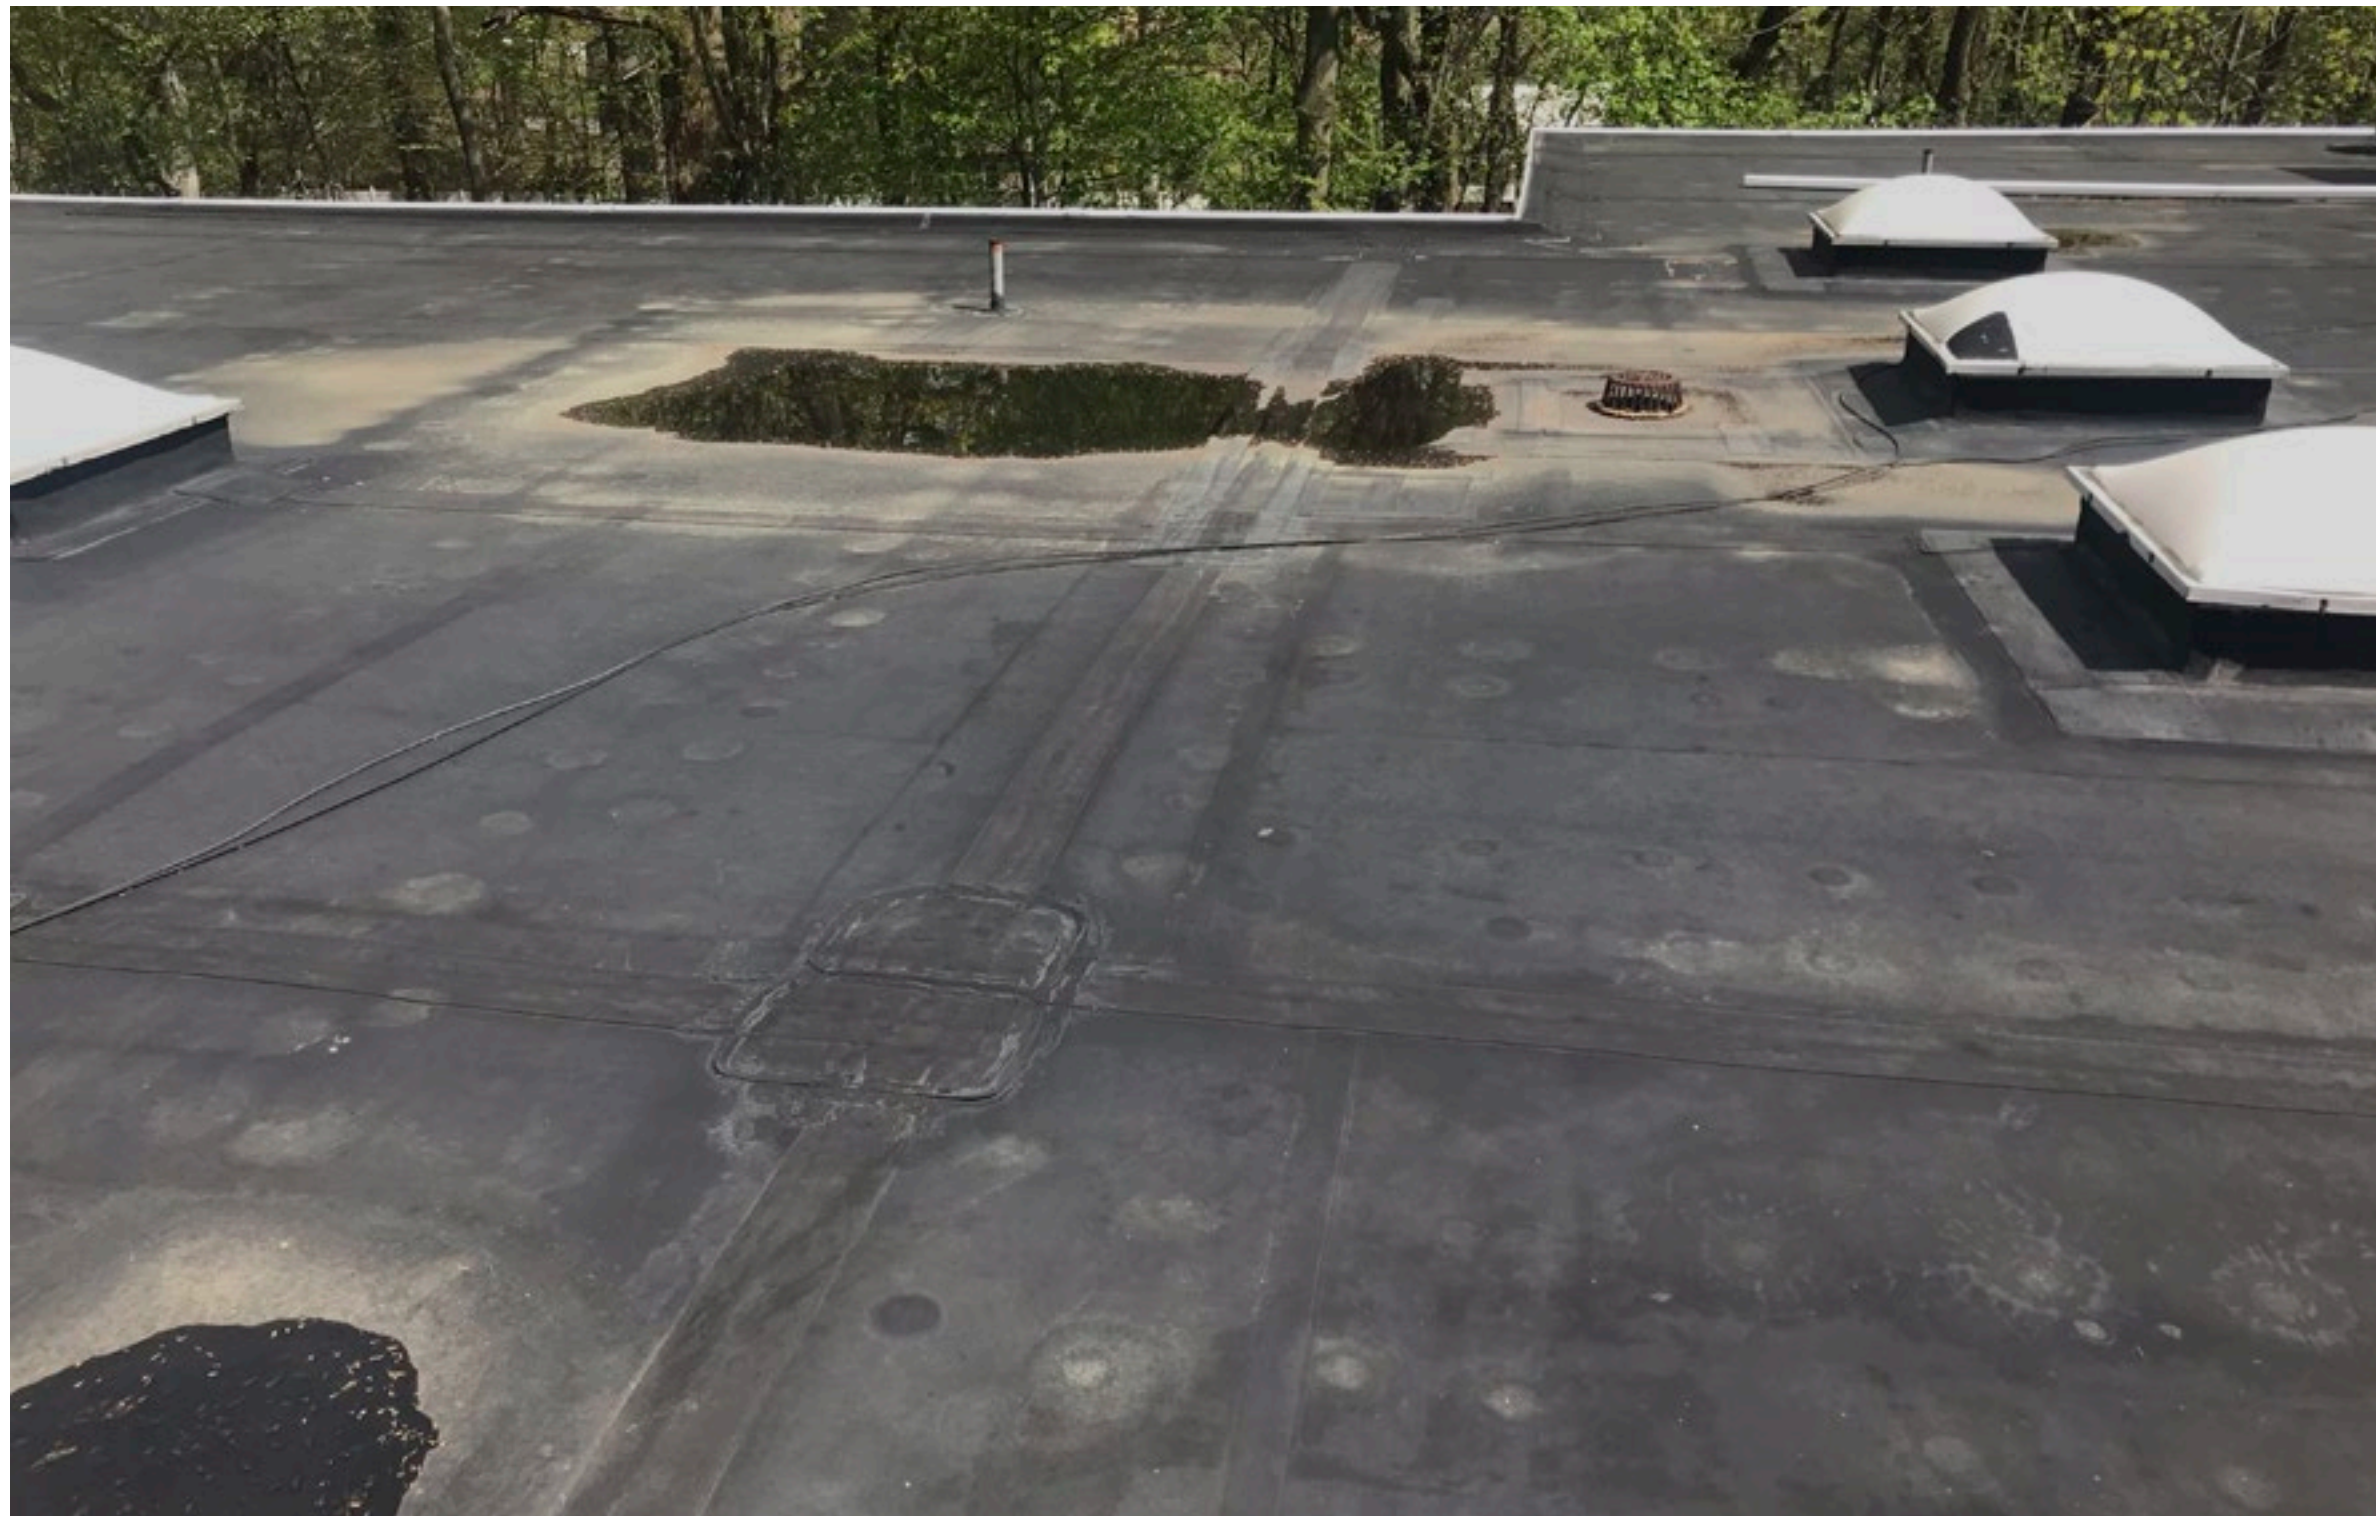
**DETERIORATED ROOF SECTION -  
RETAINING WATER AND, NOT DRAINING PROPERLY**

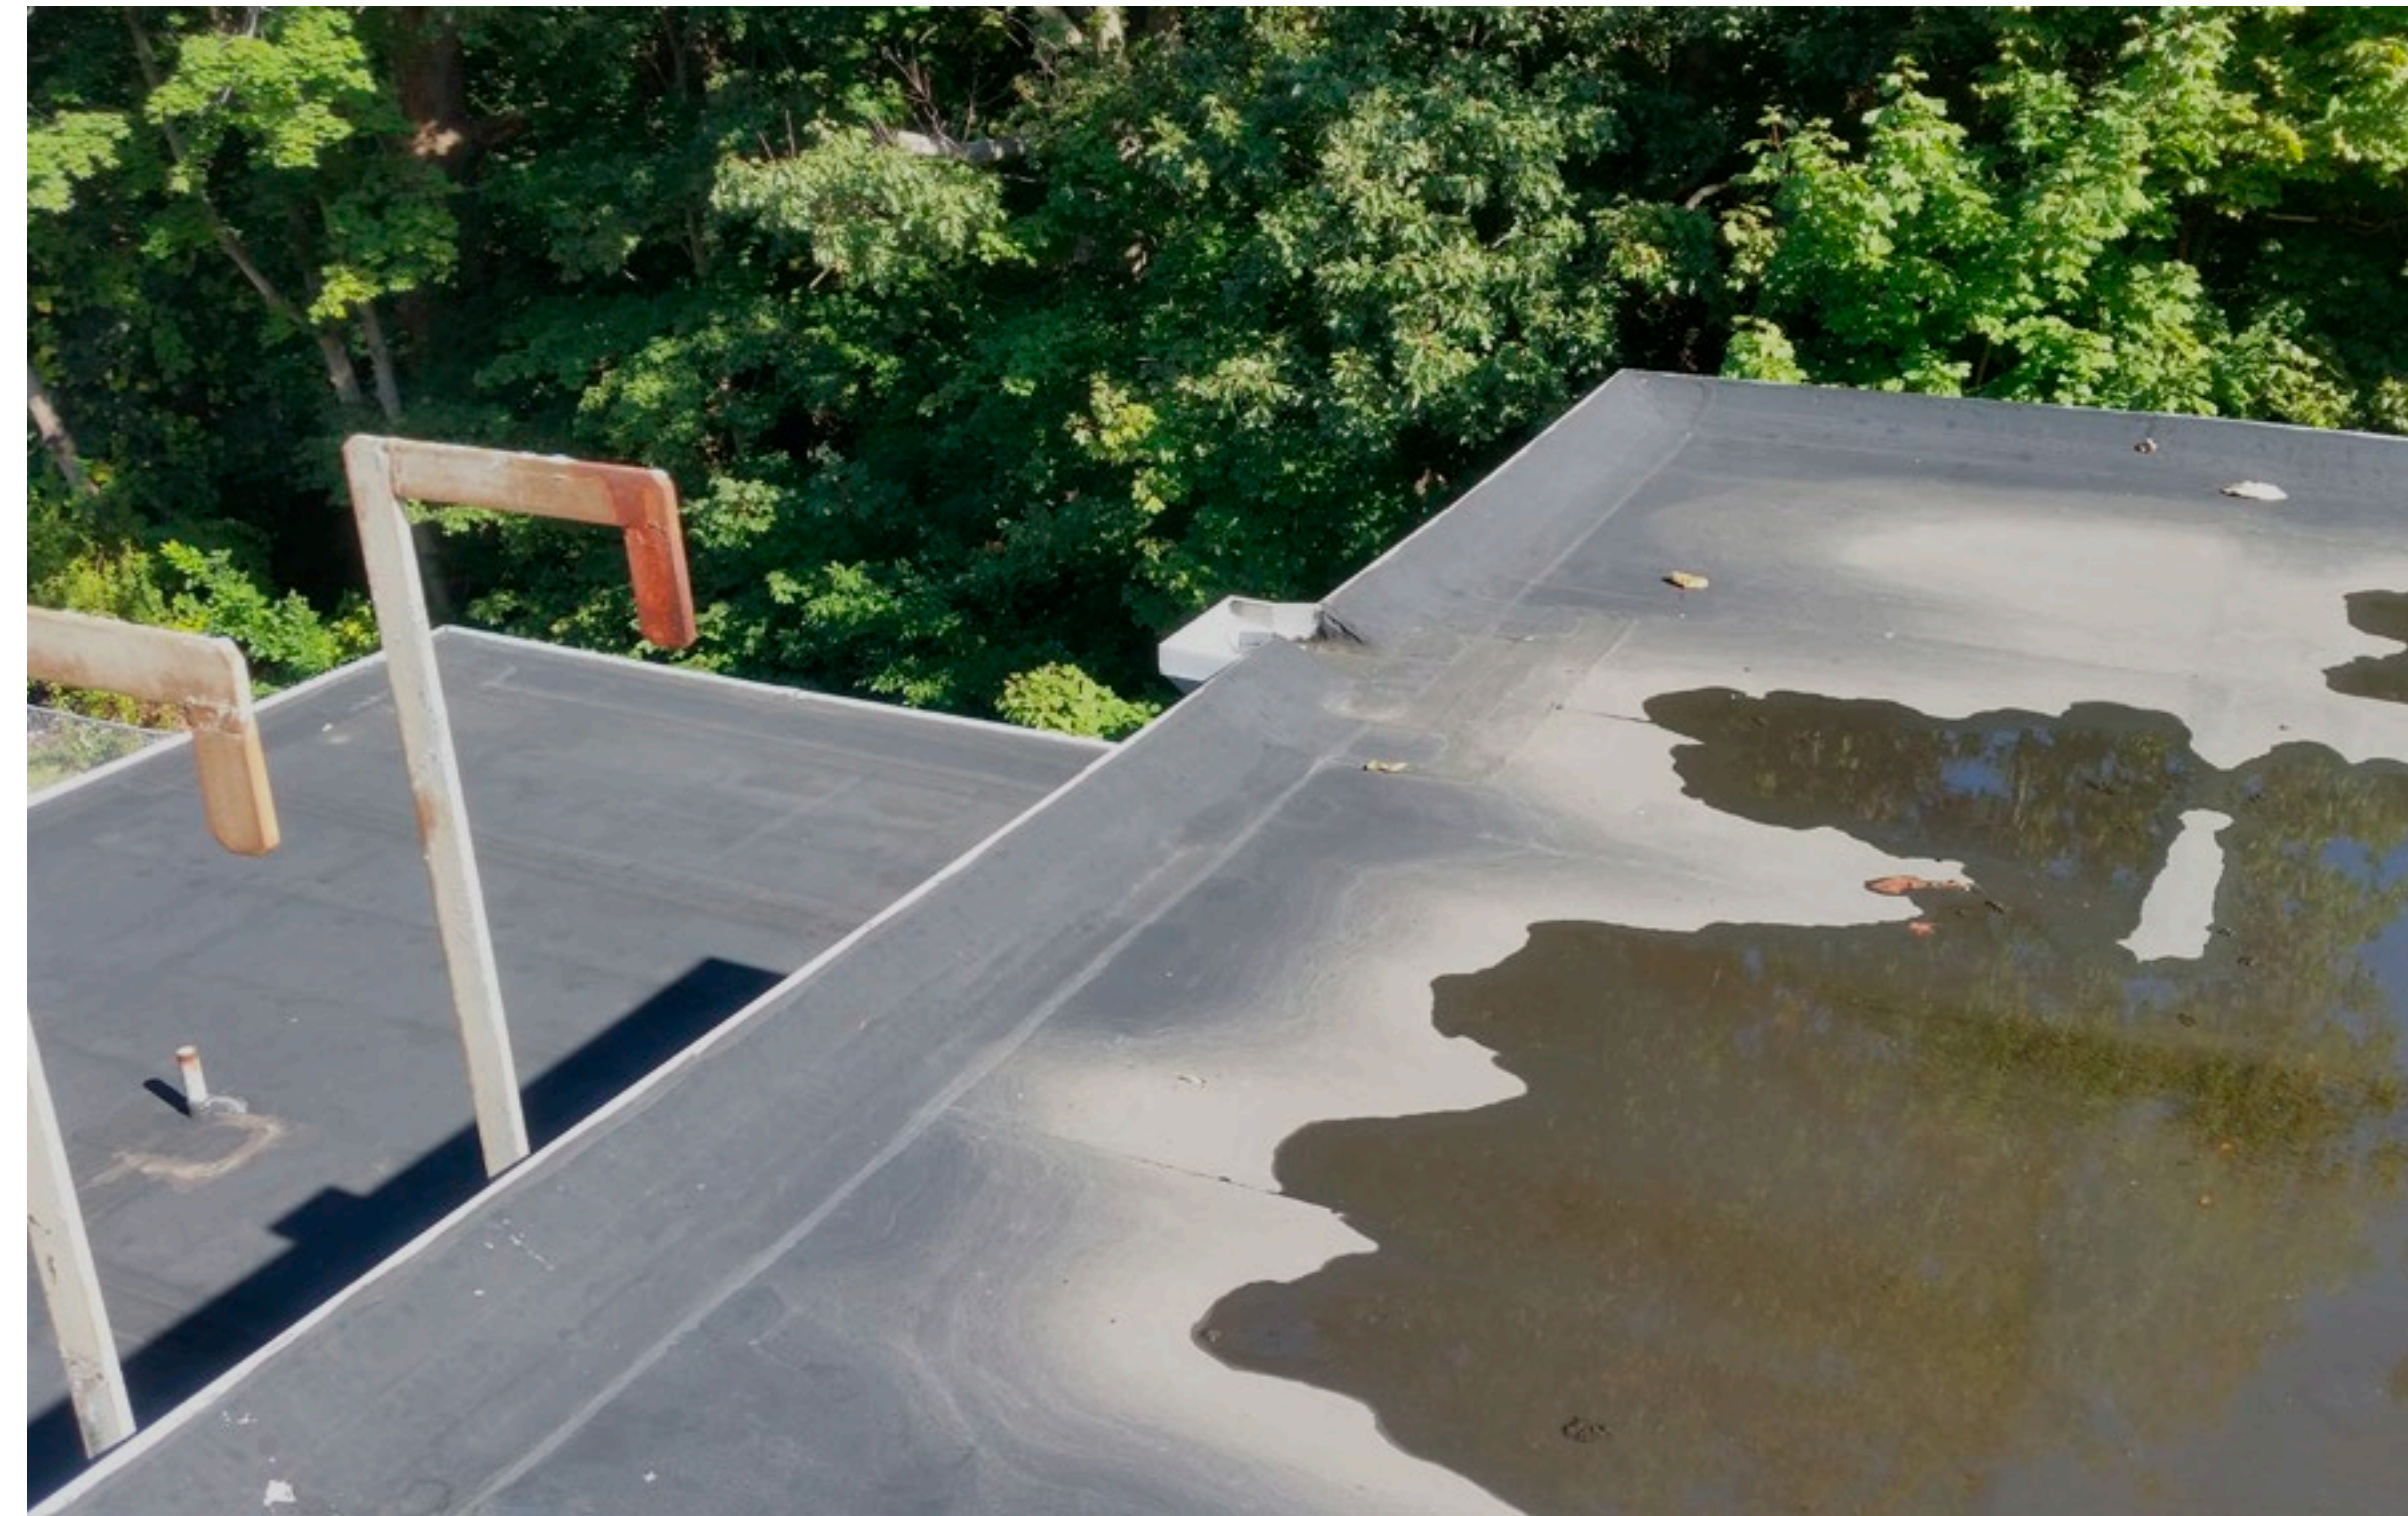
**WATER REMAINING ON ROOF  
DAYS AFTER RAIN EVENT**

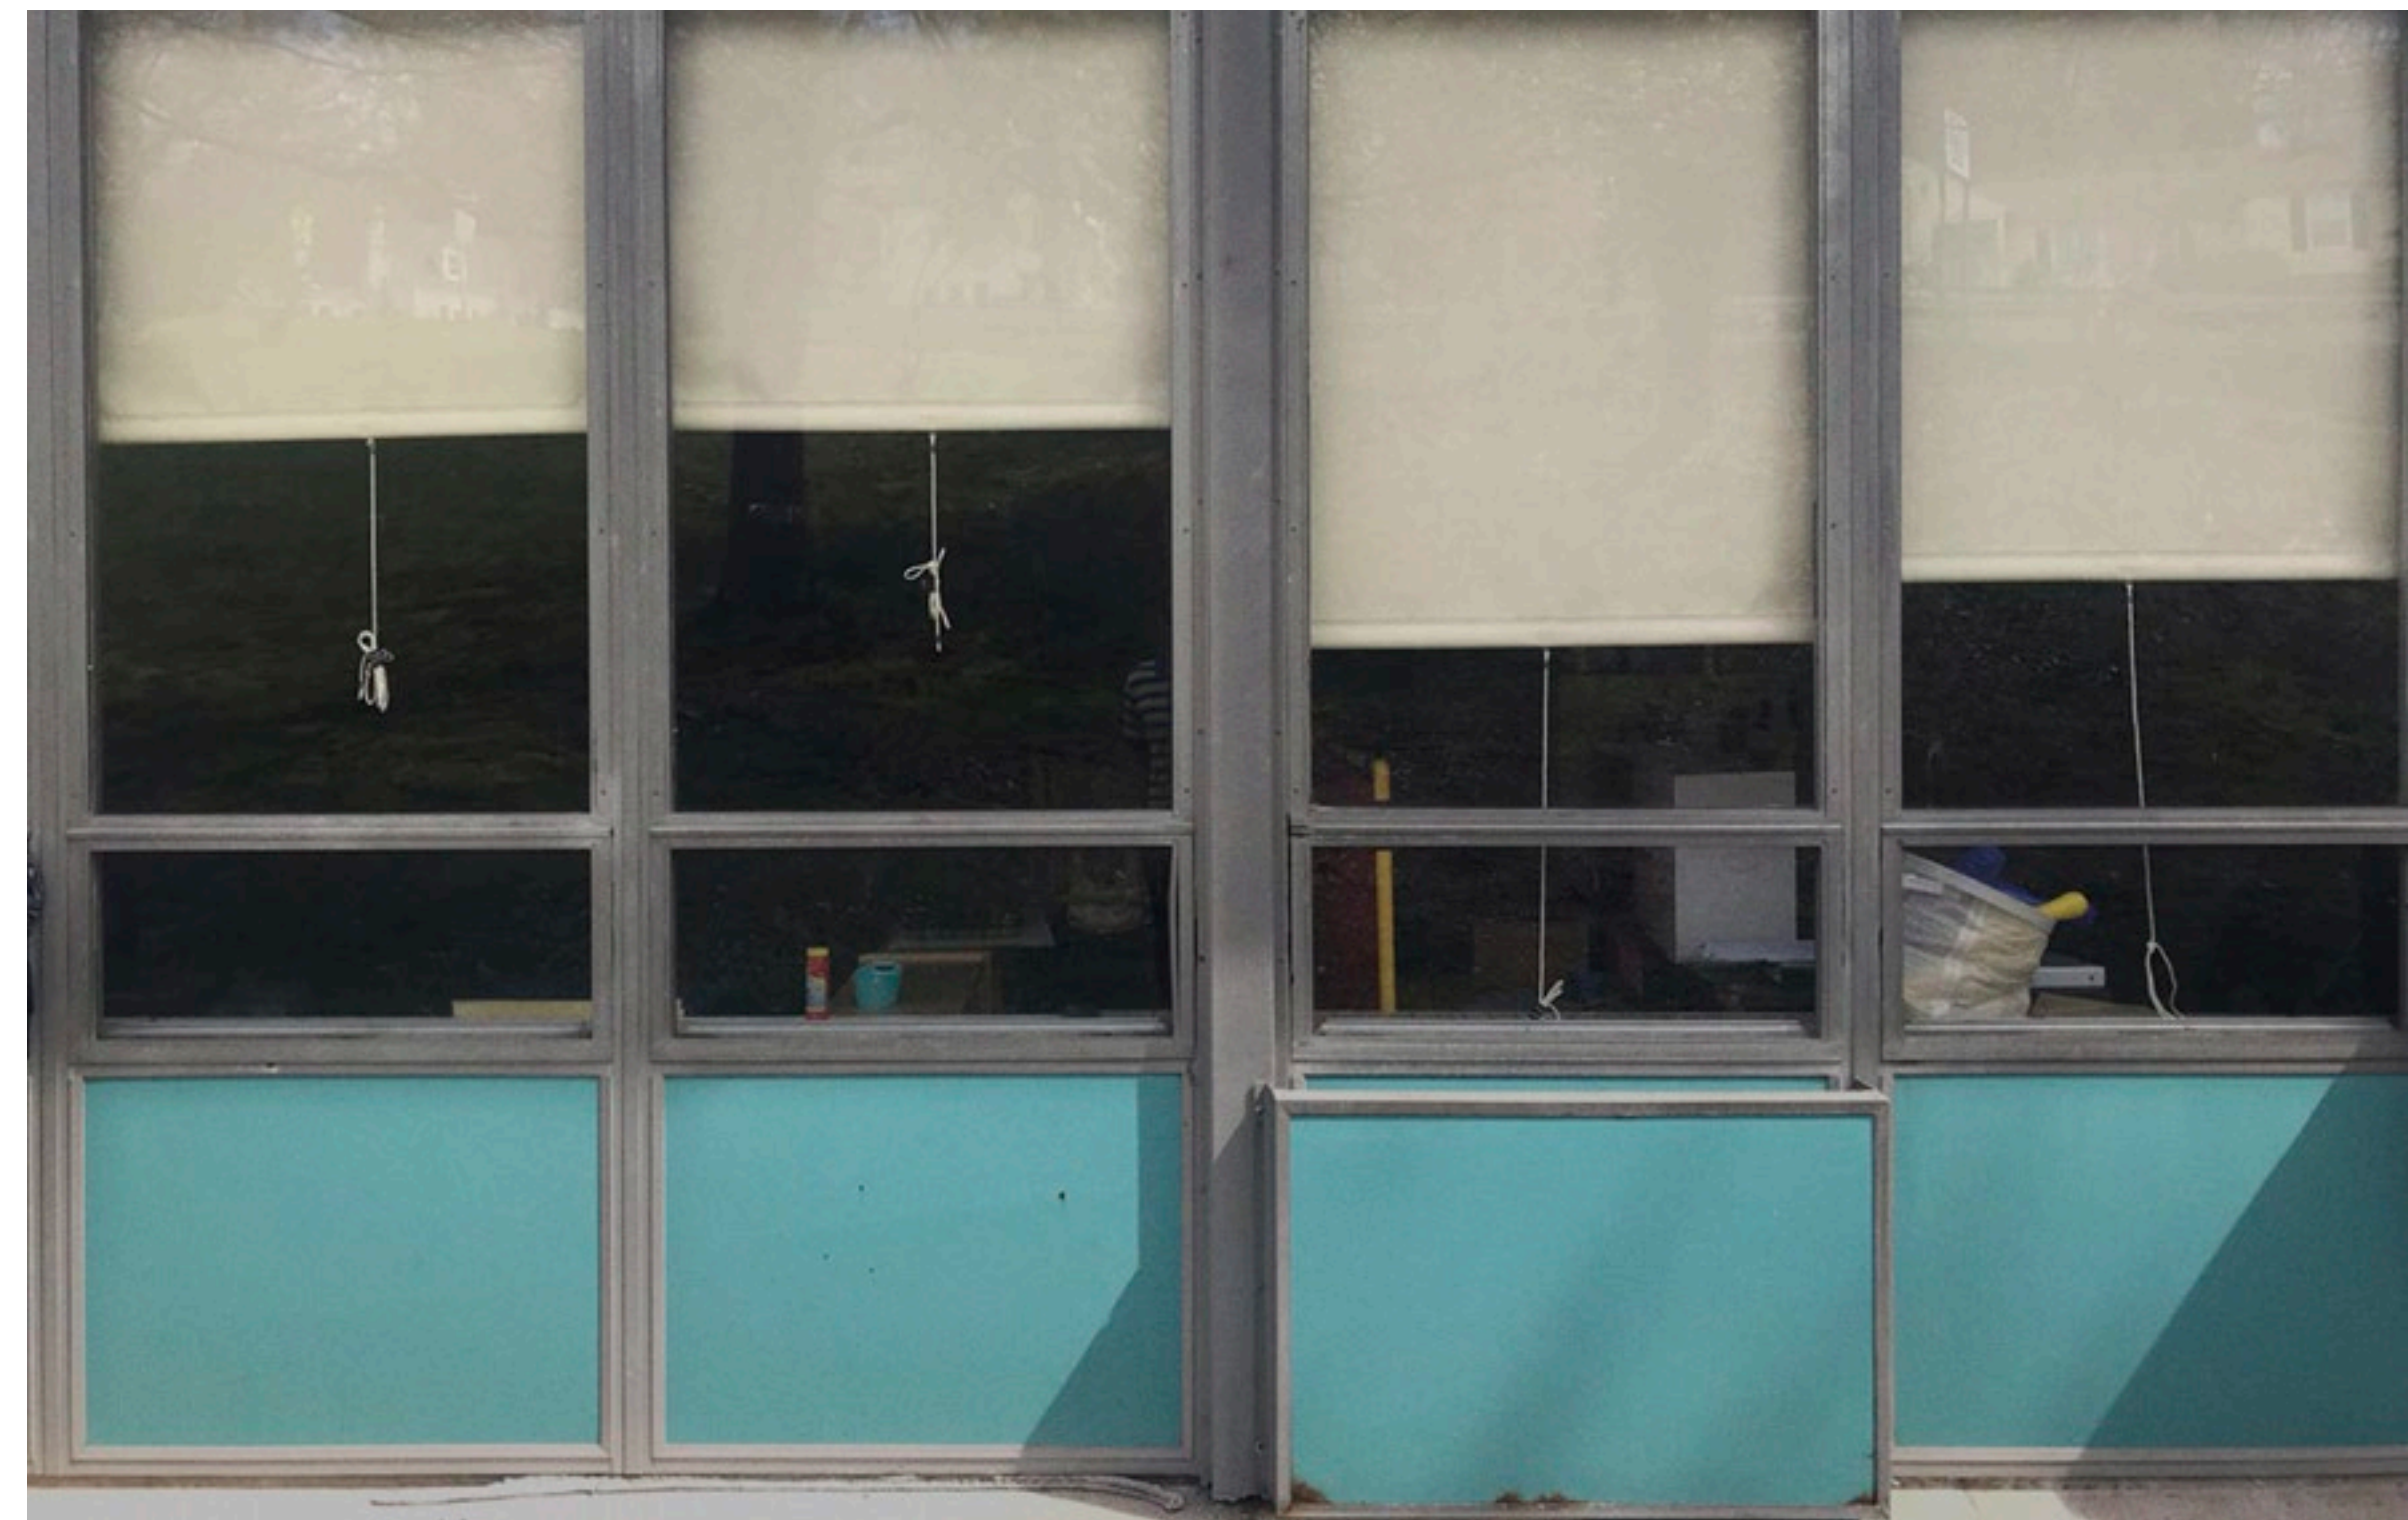
**EXISTING CURTAIN WALL SYSTEMS  
ARE SINGLE PANE AND INEFFICIENT;  
PANELS ARE BEGINNING TO RUST OUT**

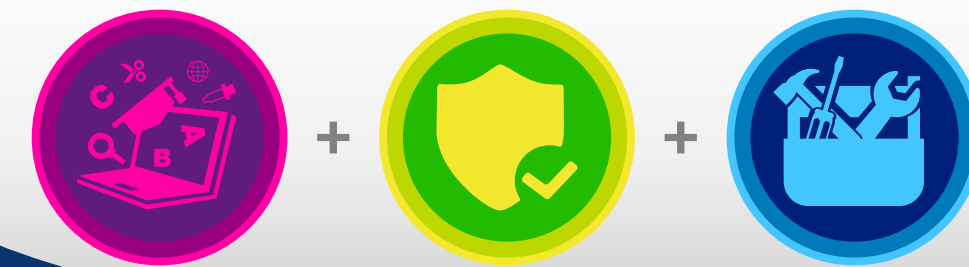
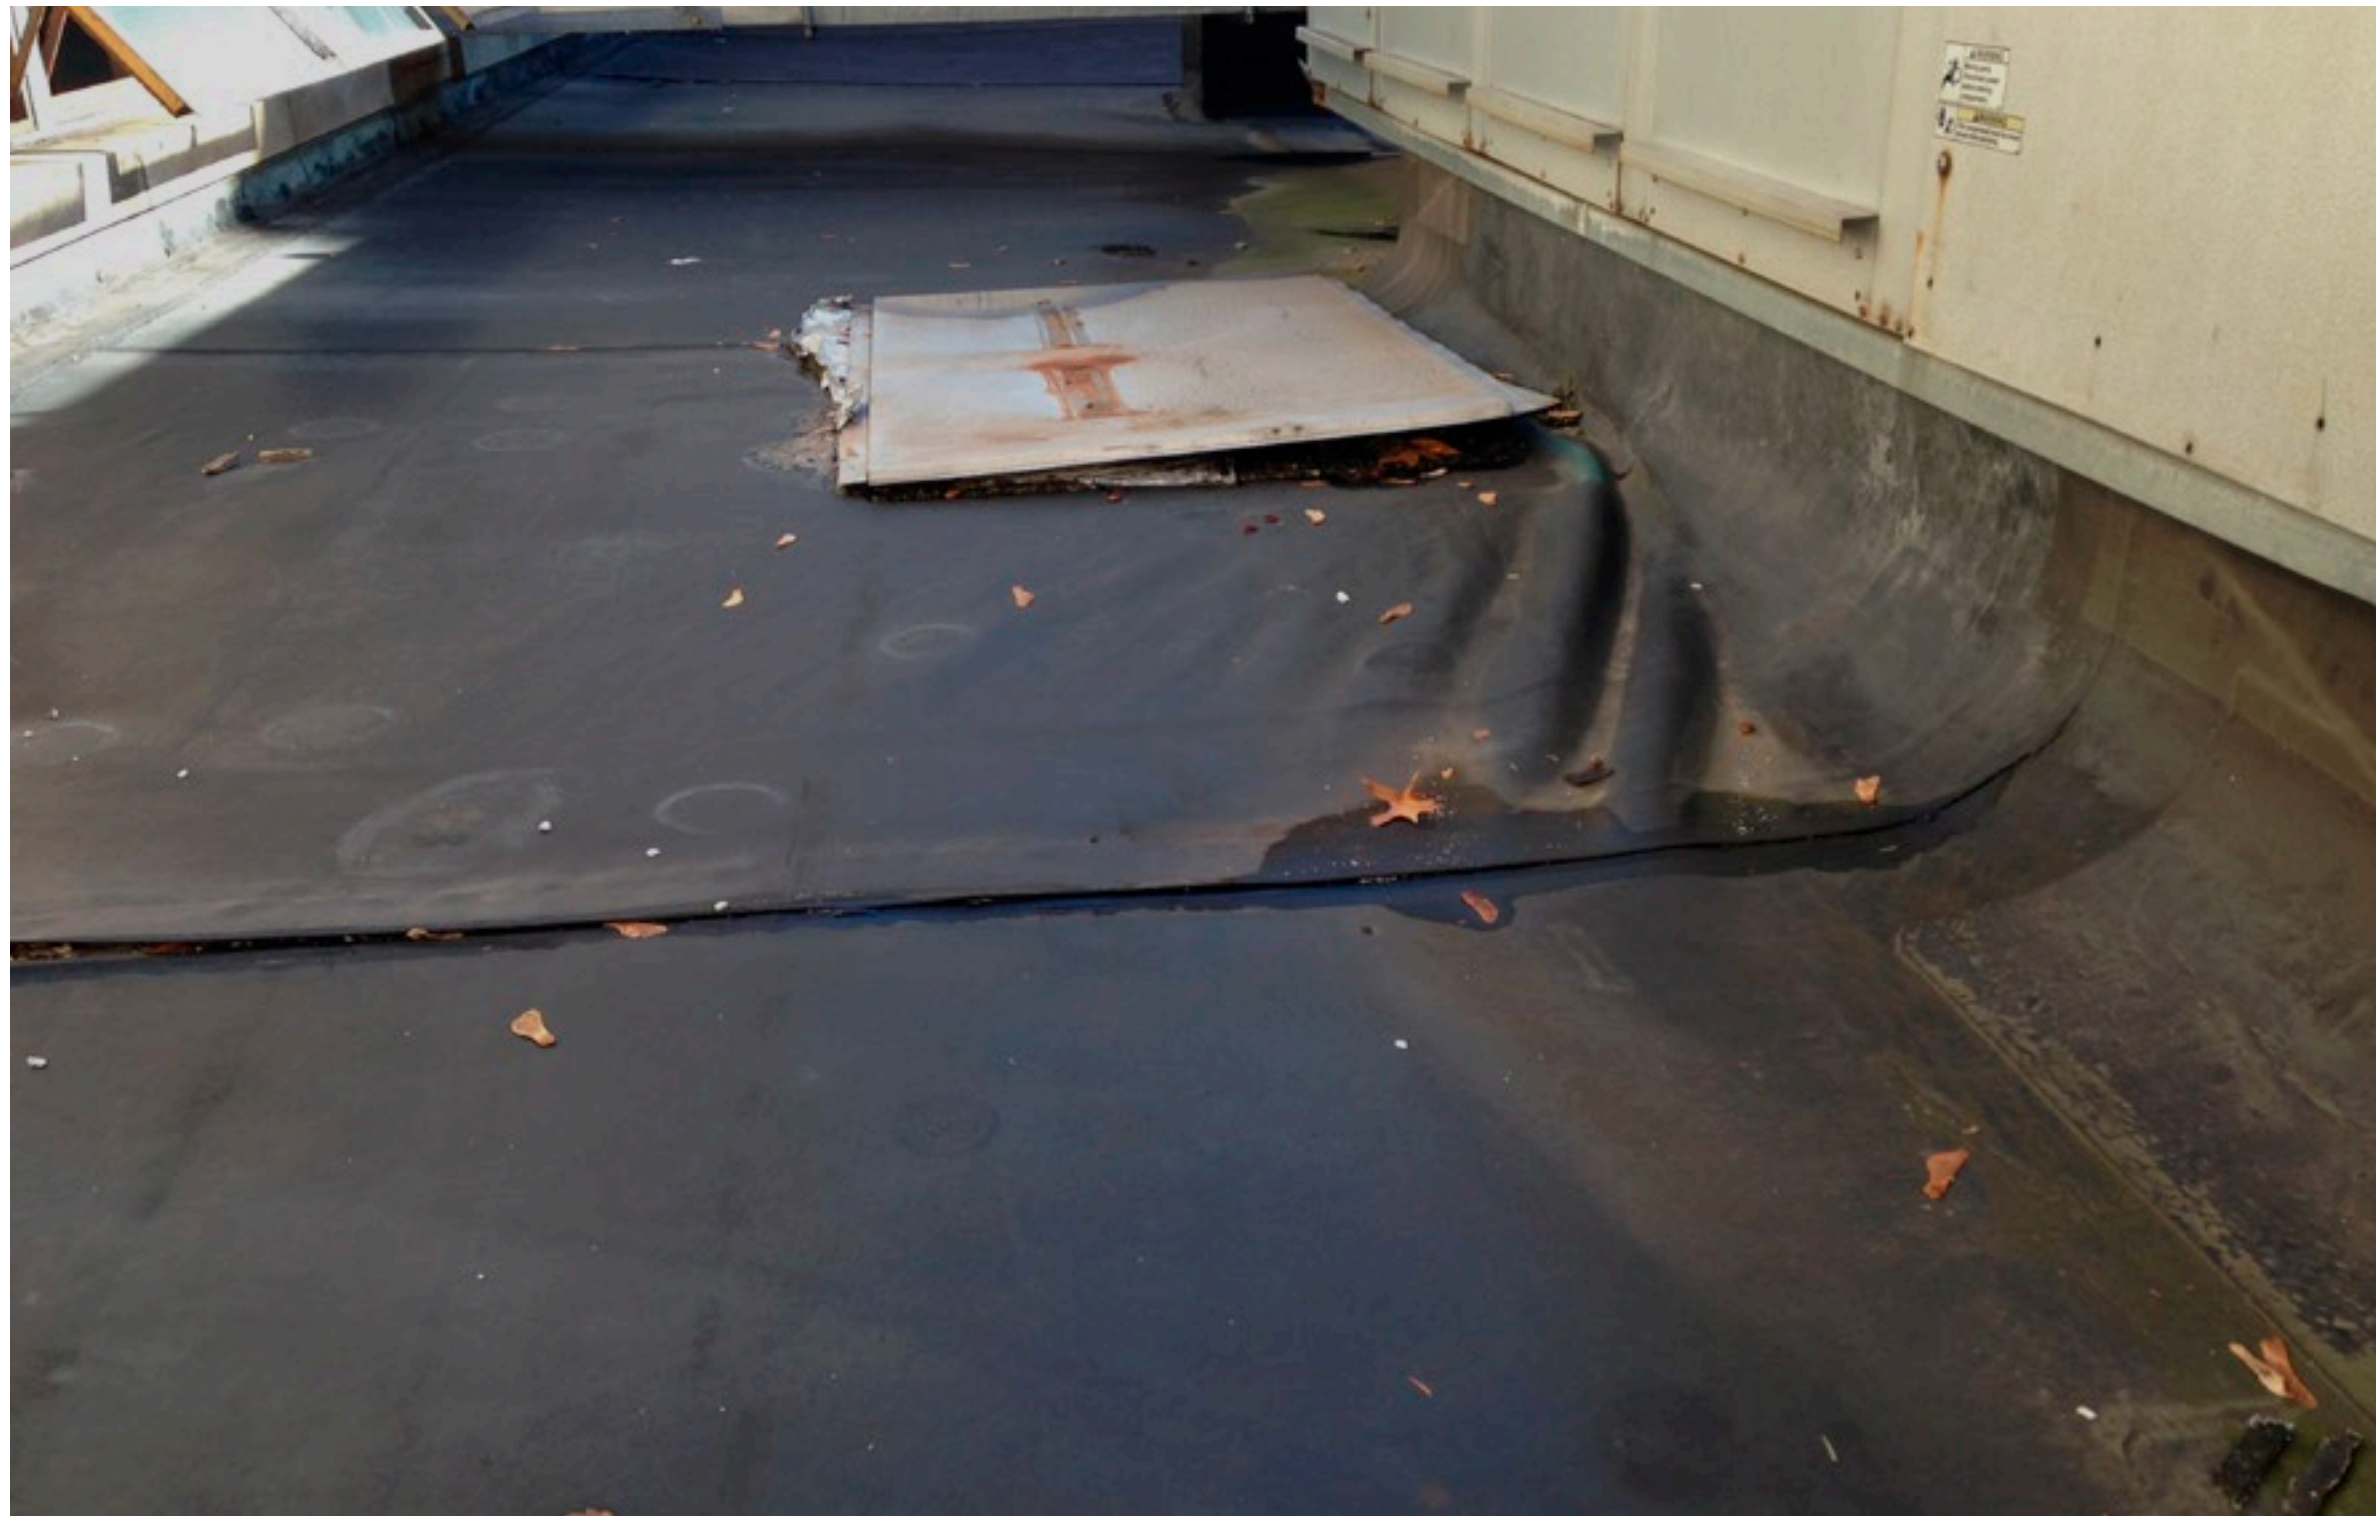
**DETERIORATED ROOF SECTION - SYSTEM NO LONGER ADHERED, WATER MAY HAVE DEVELOPED BELOW THE MEMBRANE**
