# CAPITAL PROJECTS ALL SCHOOLS

# » DISTRICT-WIDE CAPITAL PROJECTS

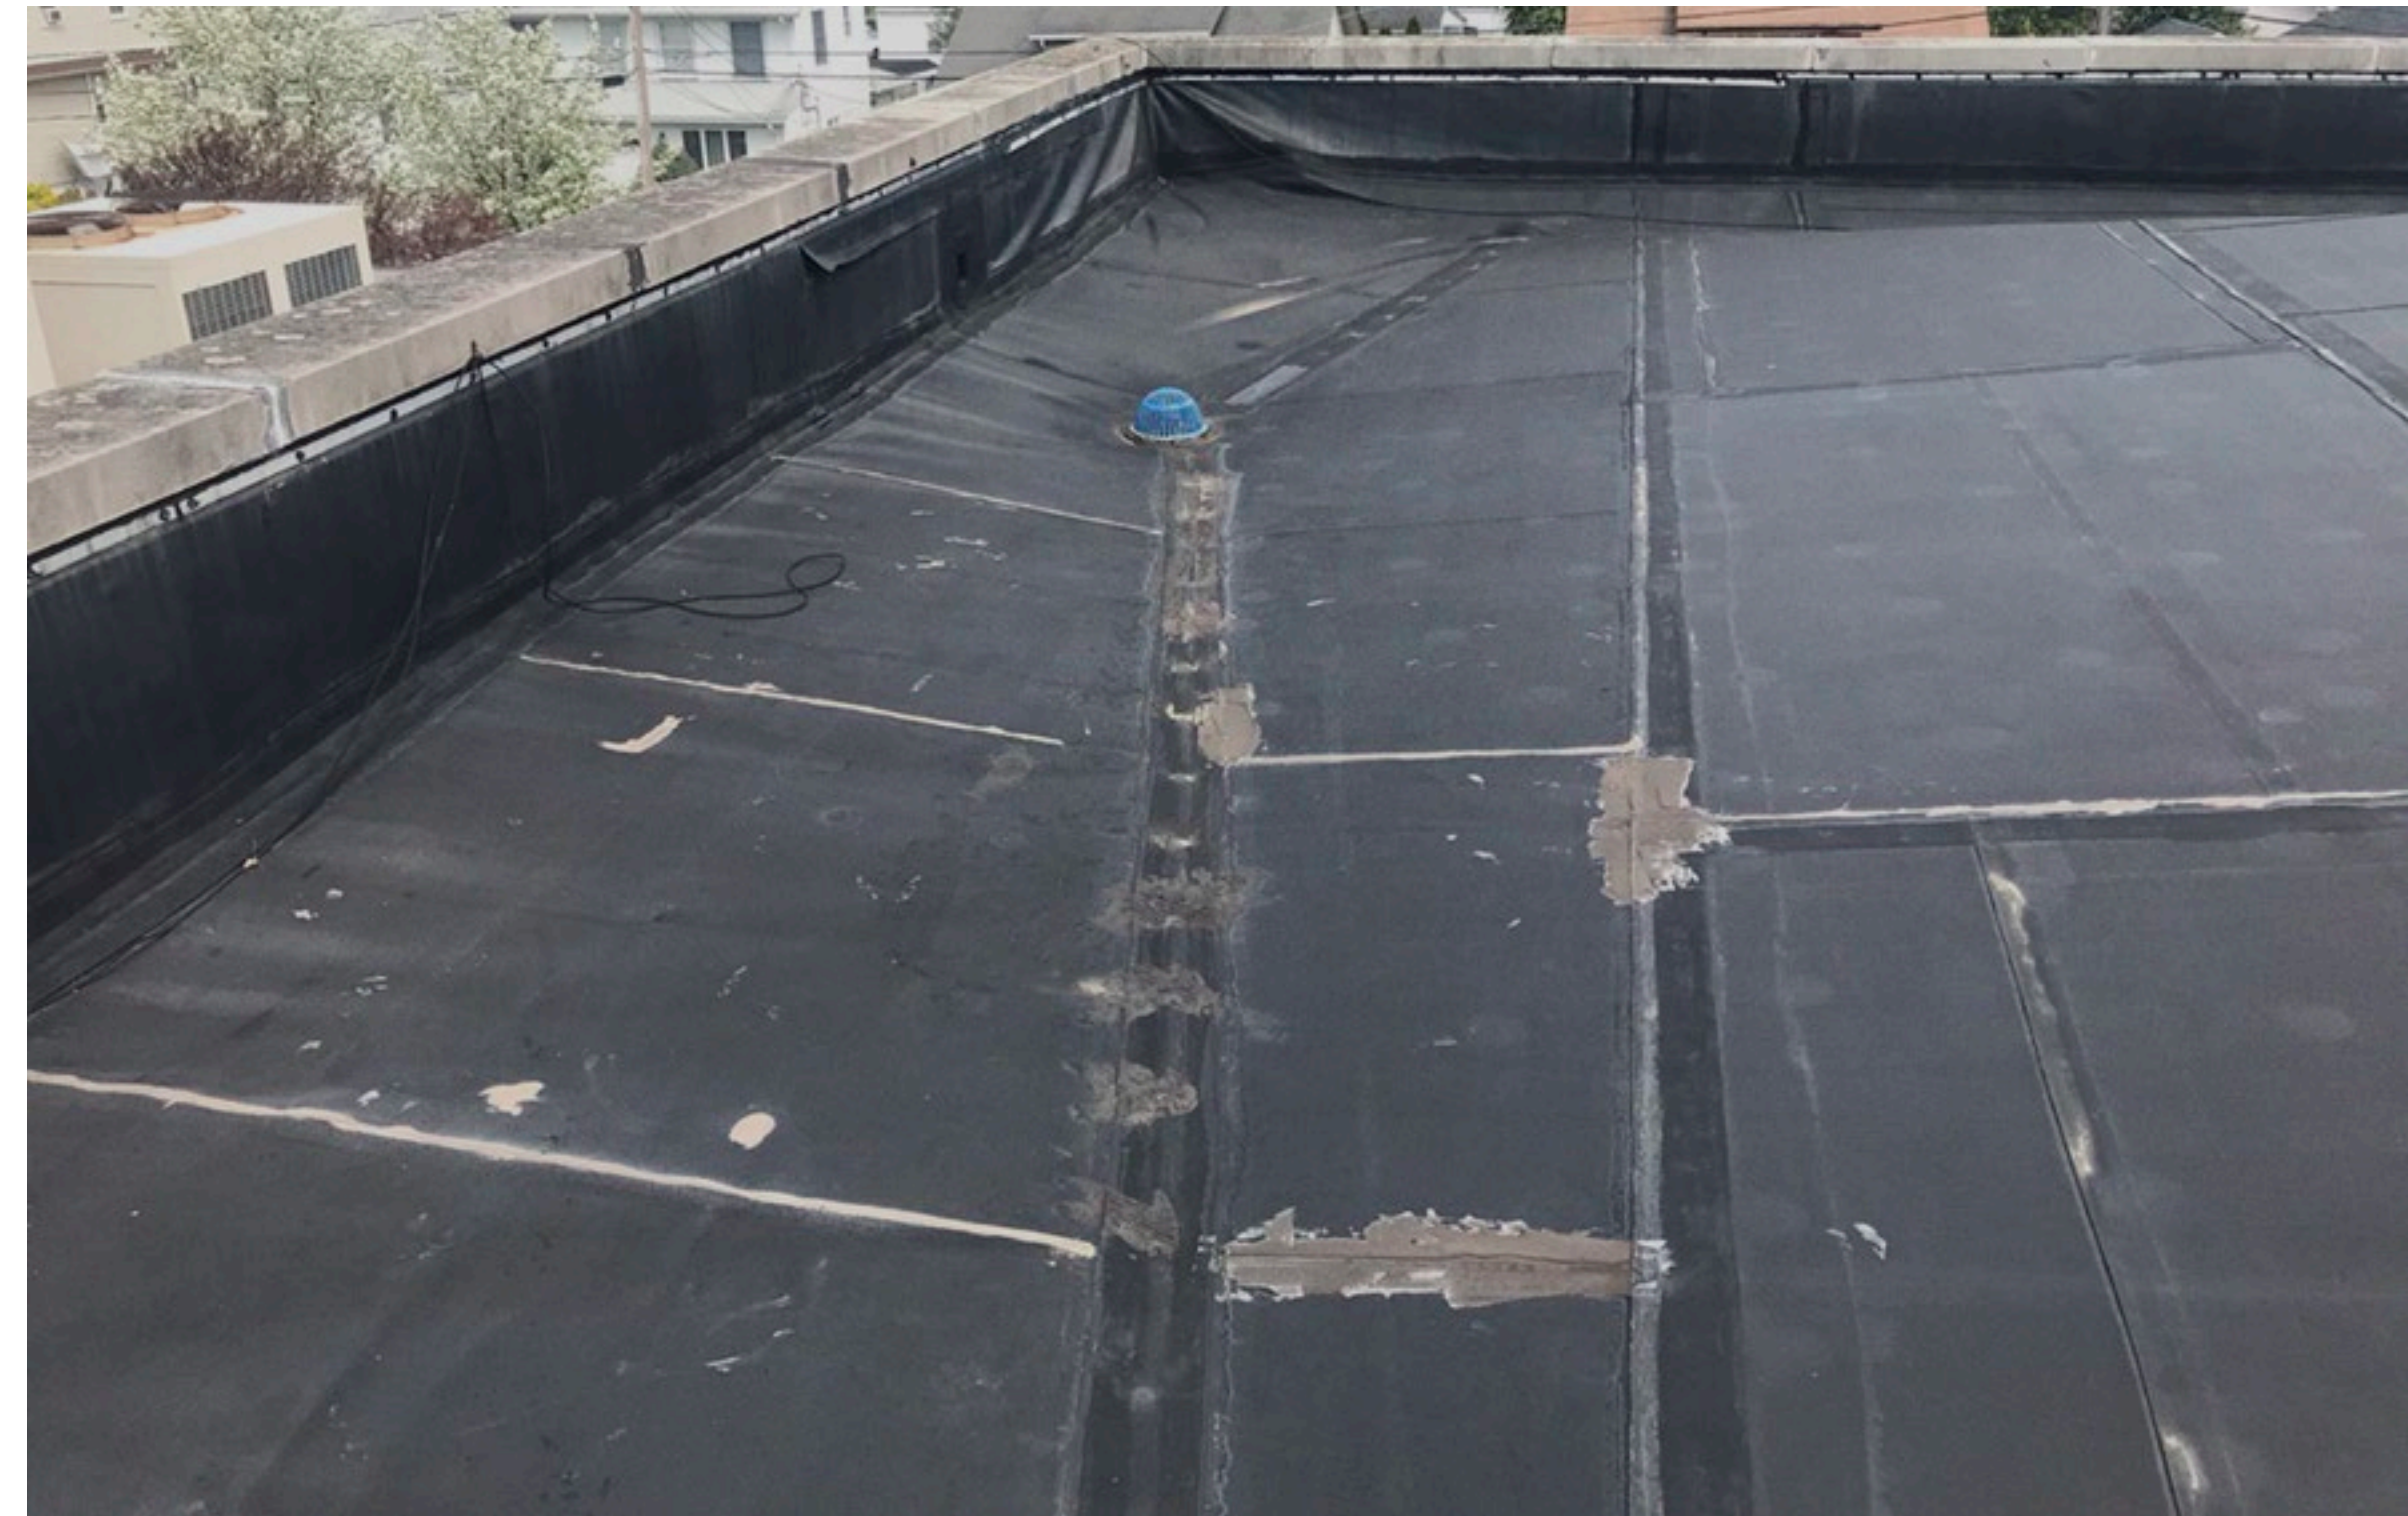
**DETERIORATED ROOF SECTION - DELAMINATIONS OF ROOF MEMBRANE; PATCHWORK OF SEAMS THROUGHOUT**

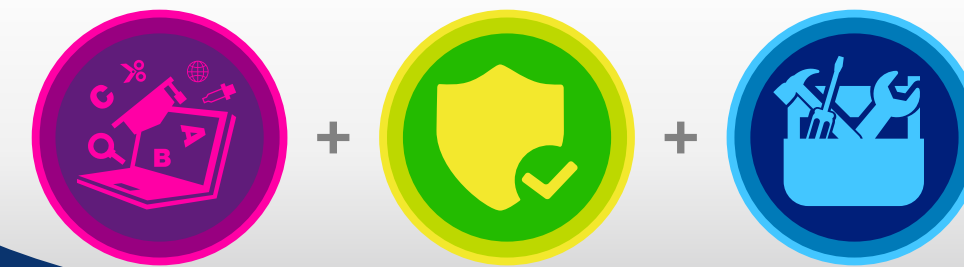
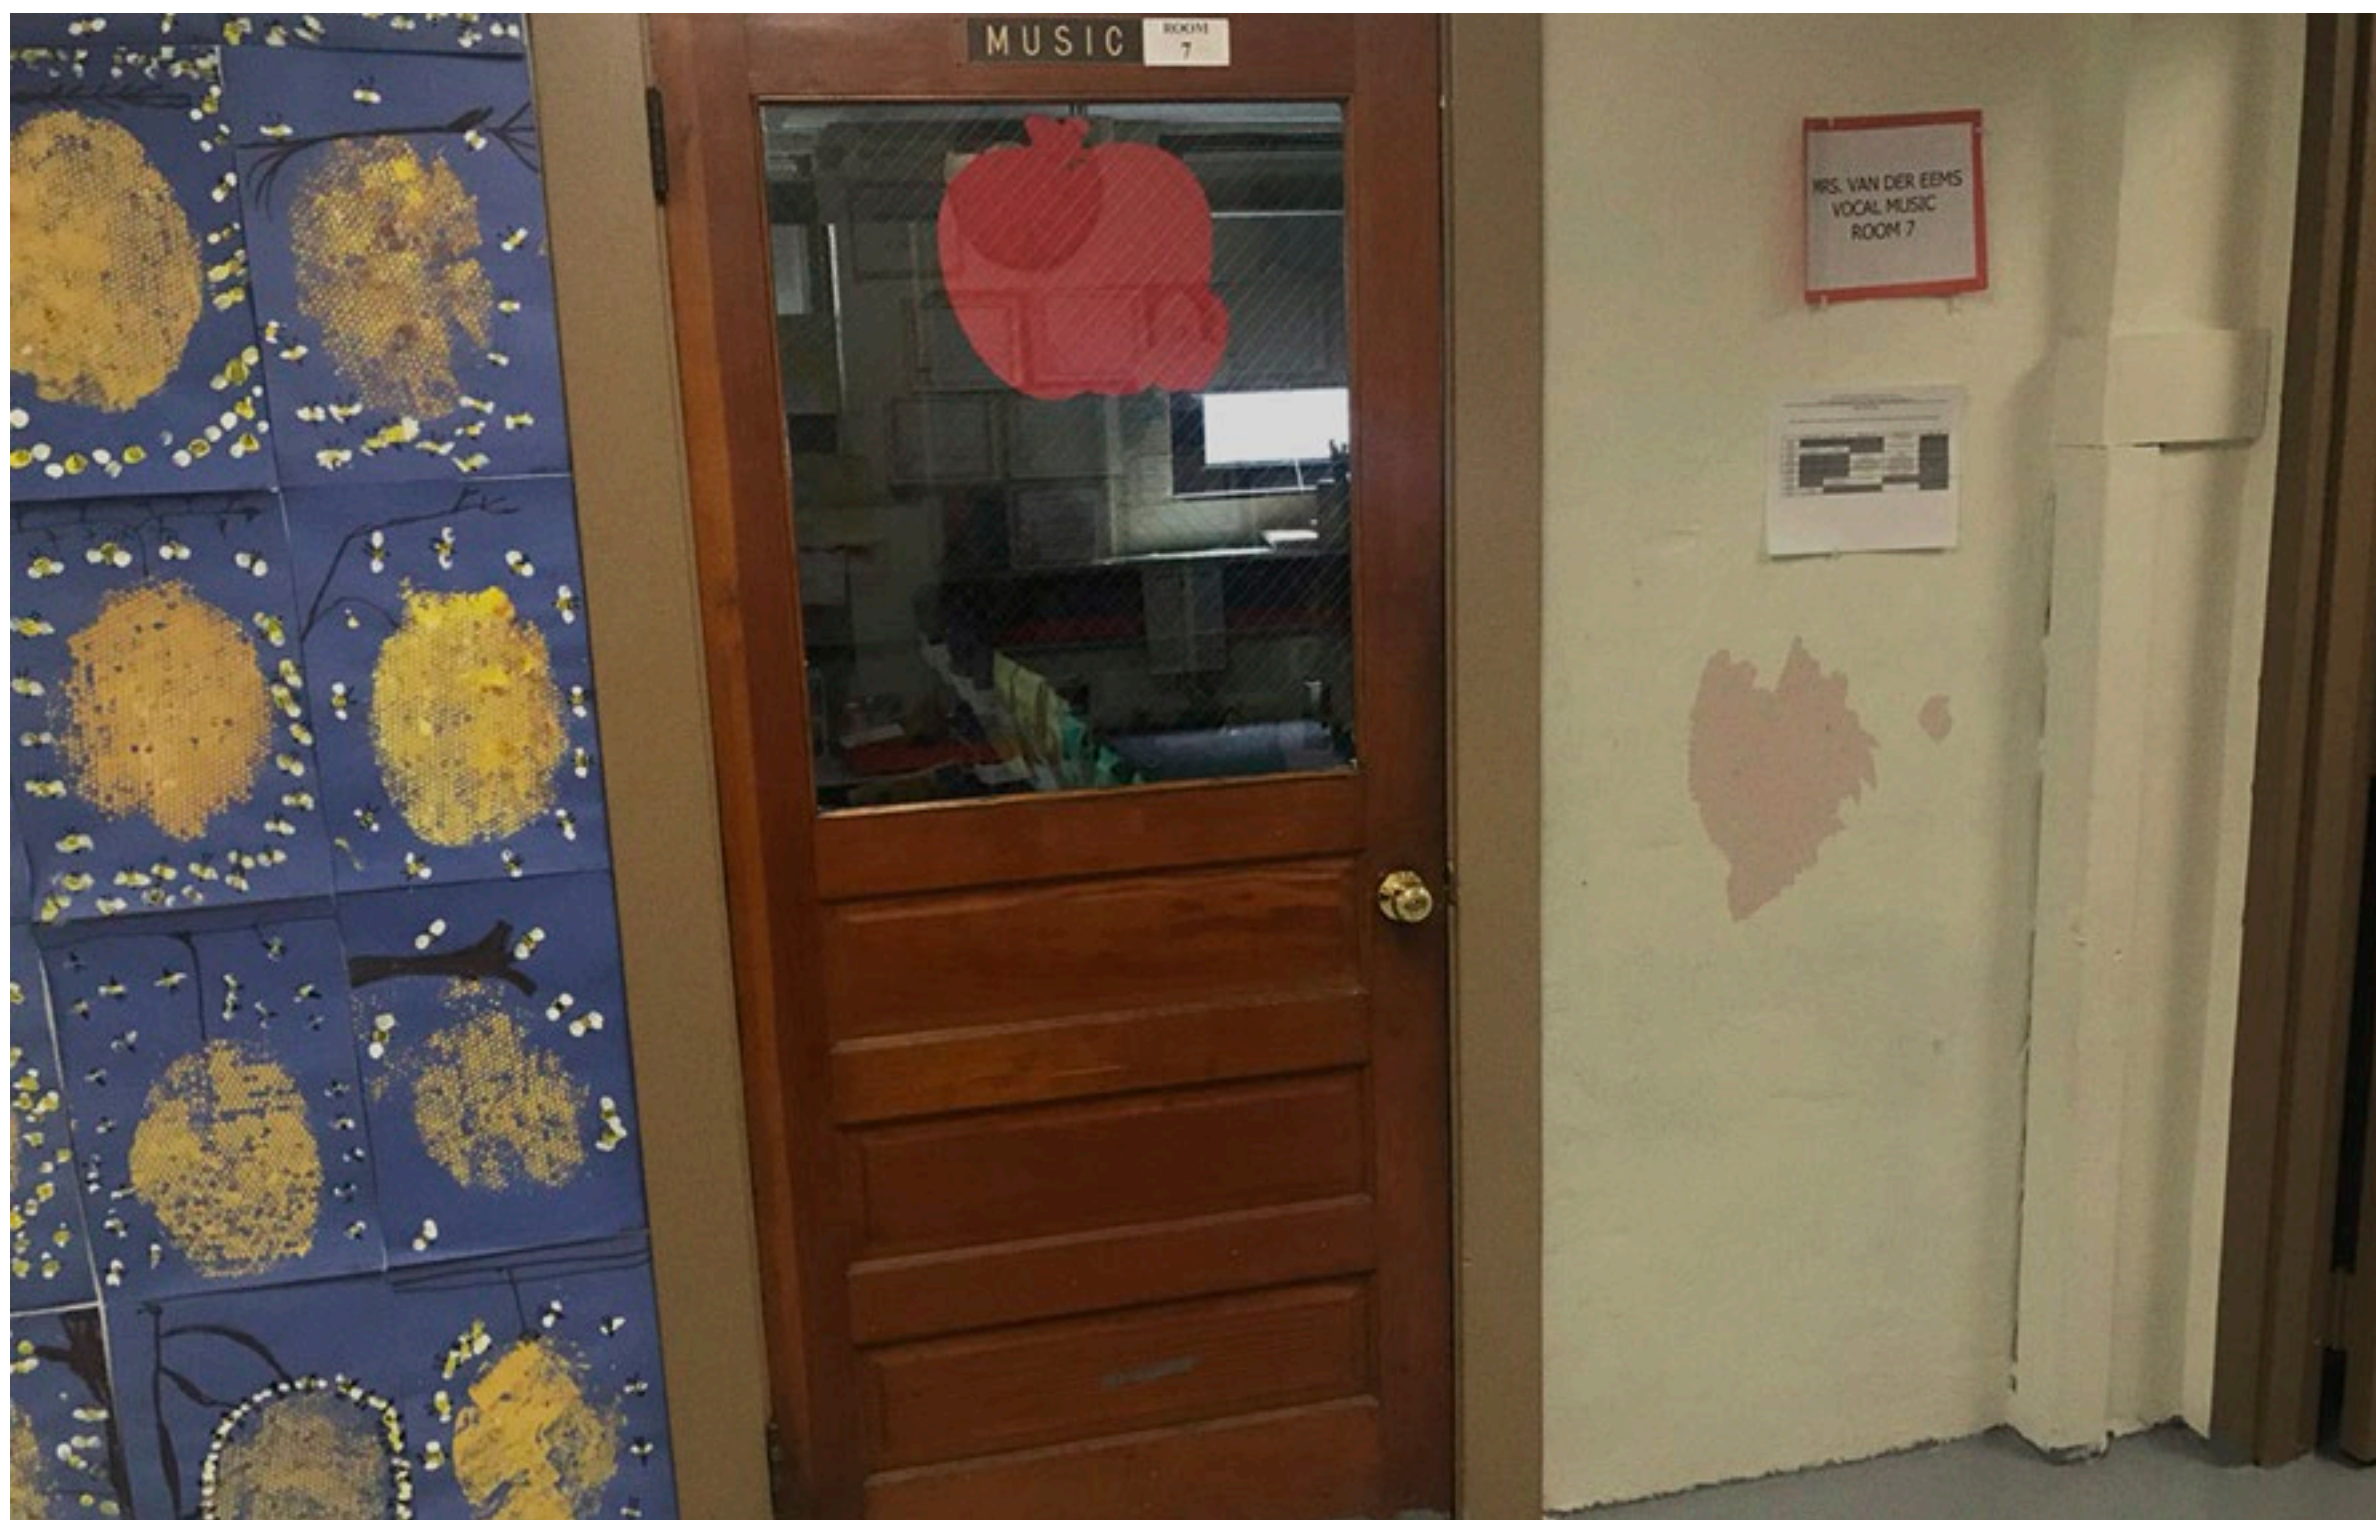
**DOOR HARDWARE AND LARGE VISION PANEL, DO NOT MEET A.D.A. OR LOCKDOWN STANDARDS**

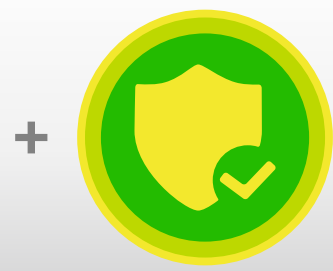
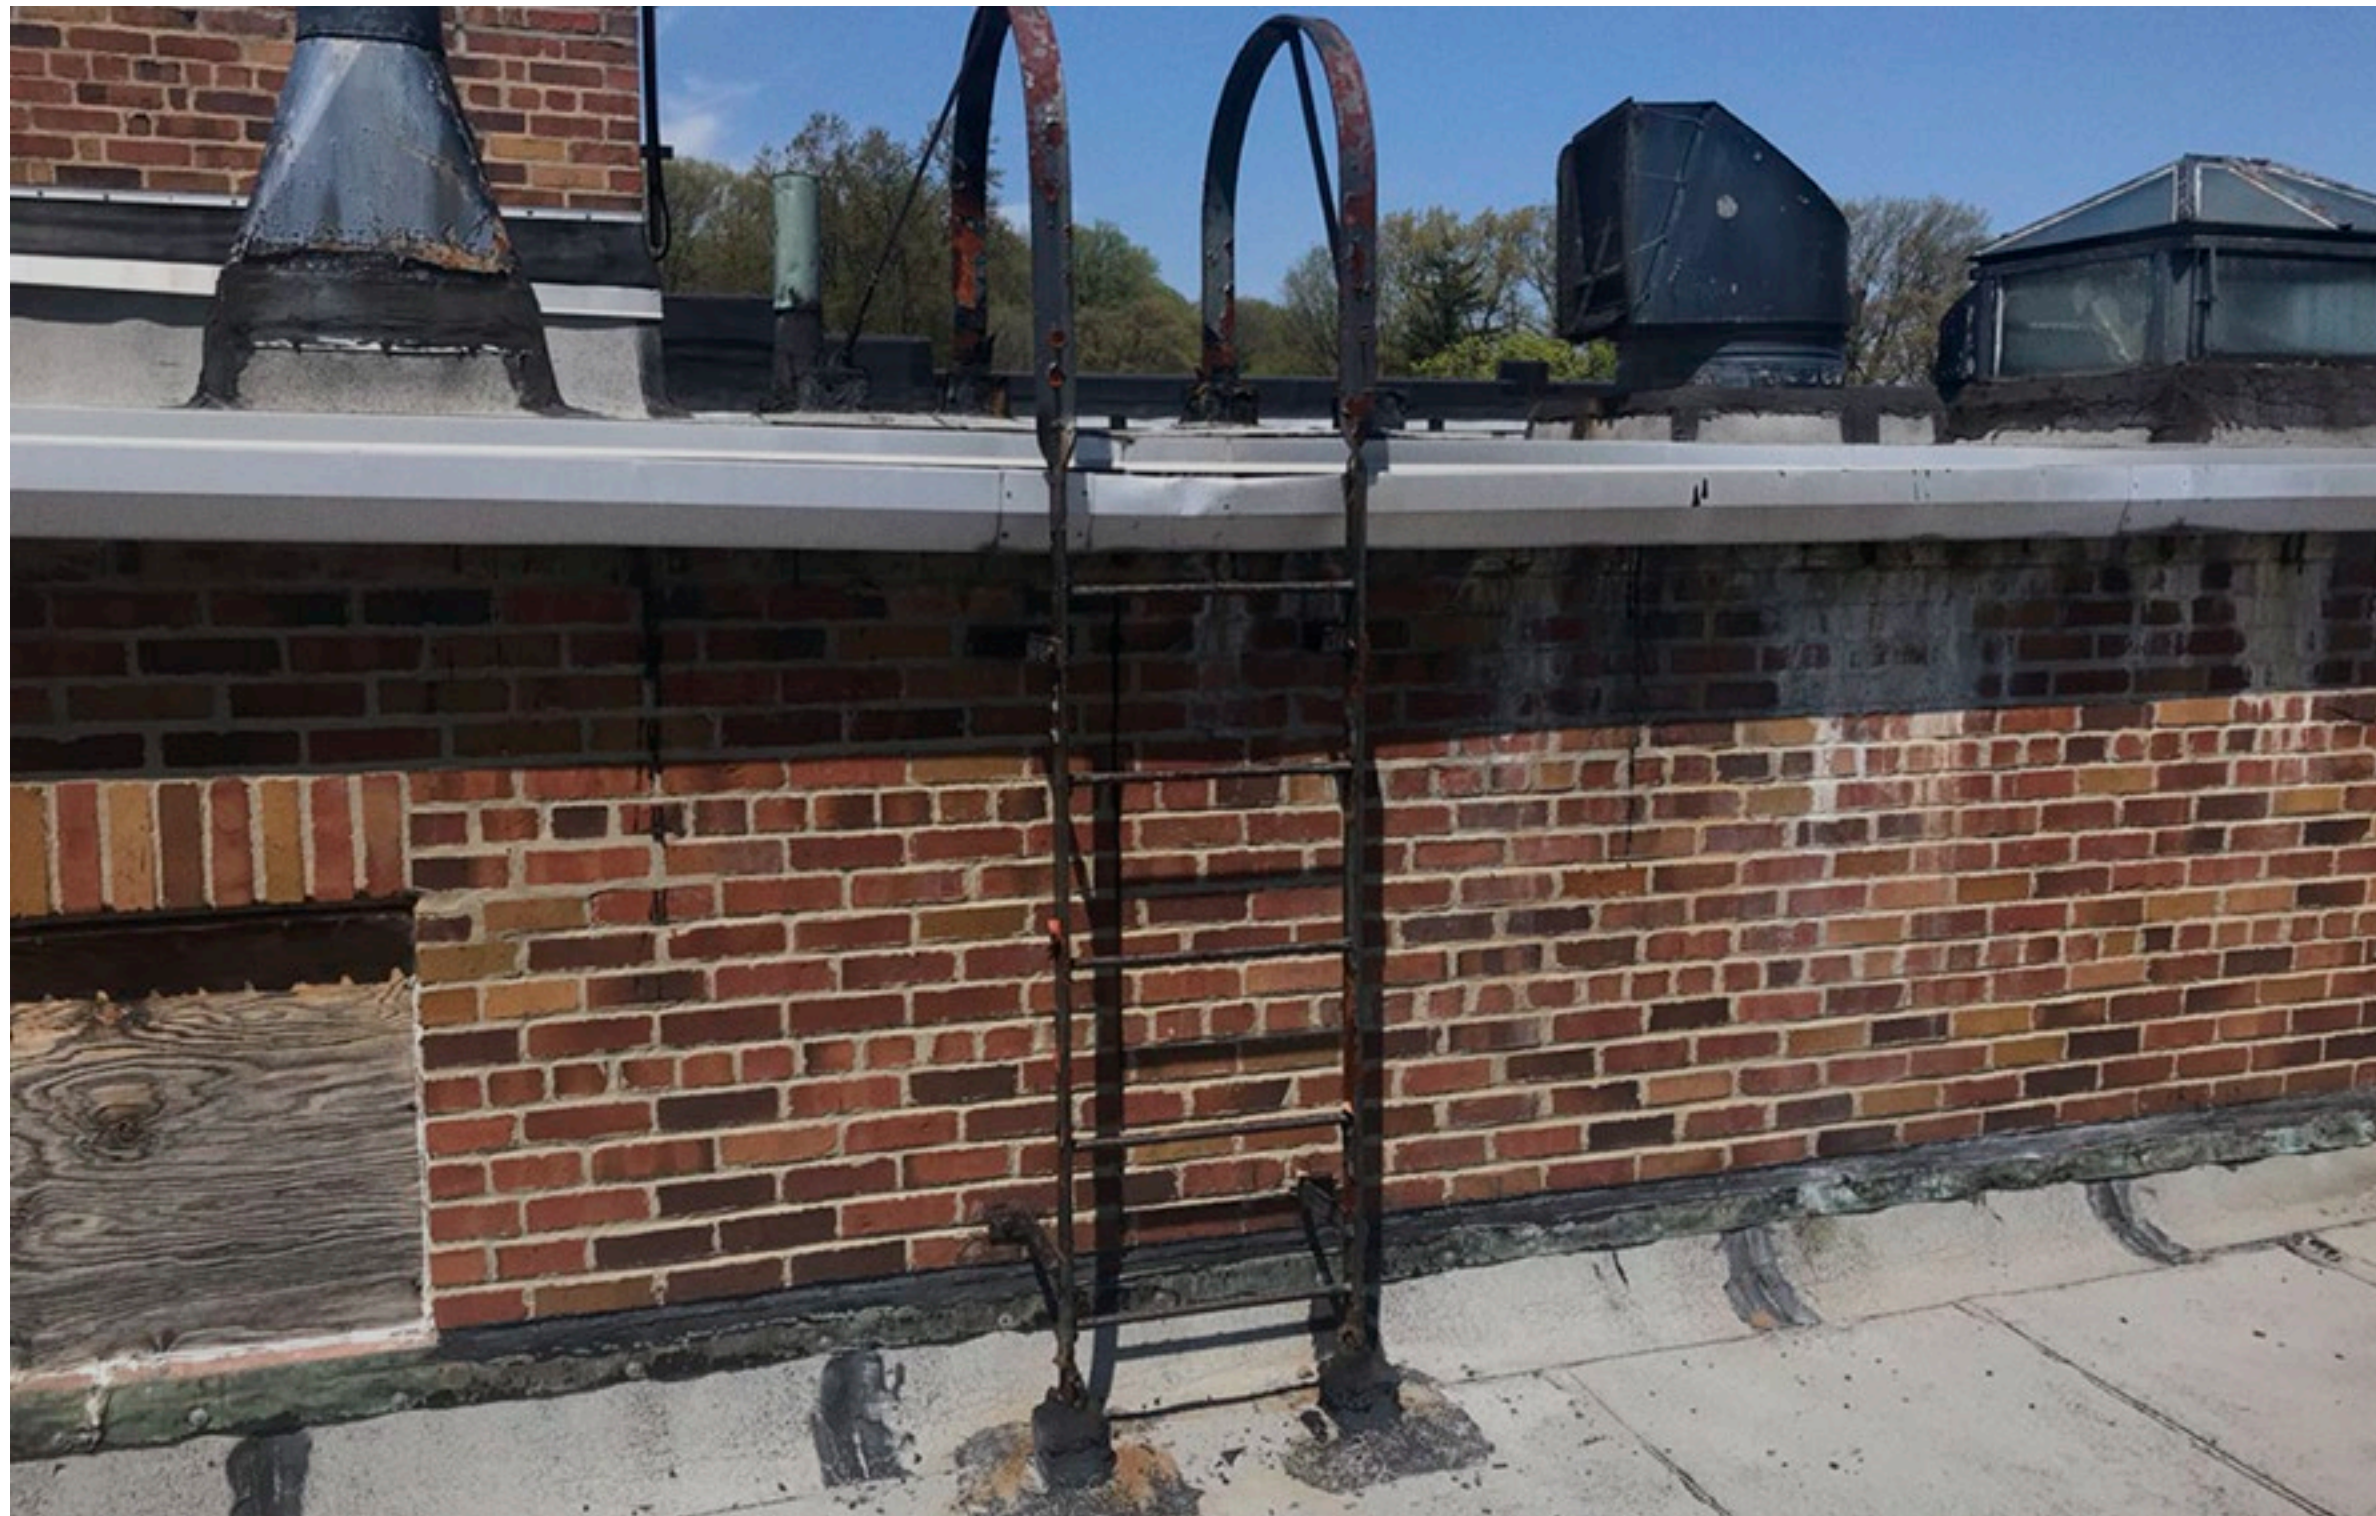
**ROOF FLASHING HAS BEEN REPAIRED MULTIPLE TIMES; EFFLORESCENCE ON MASONRY WALL IS INDICATION OF WATER PENETRATION FROM ABOVE**

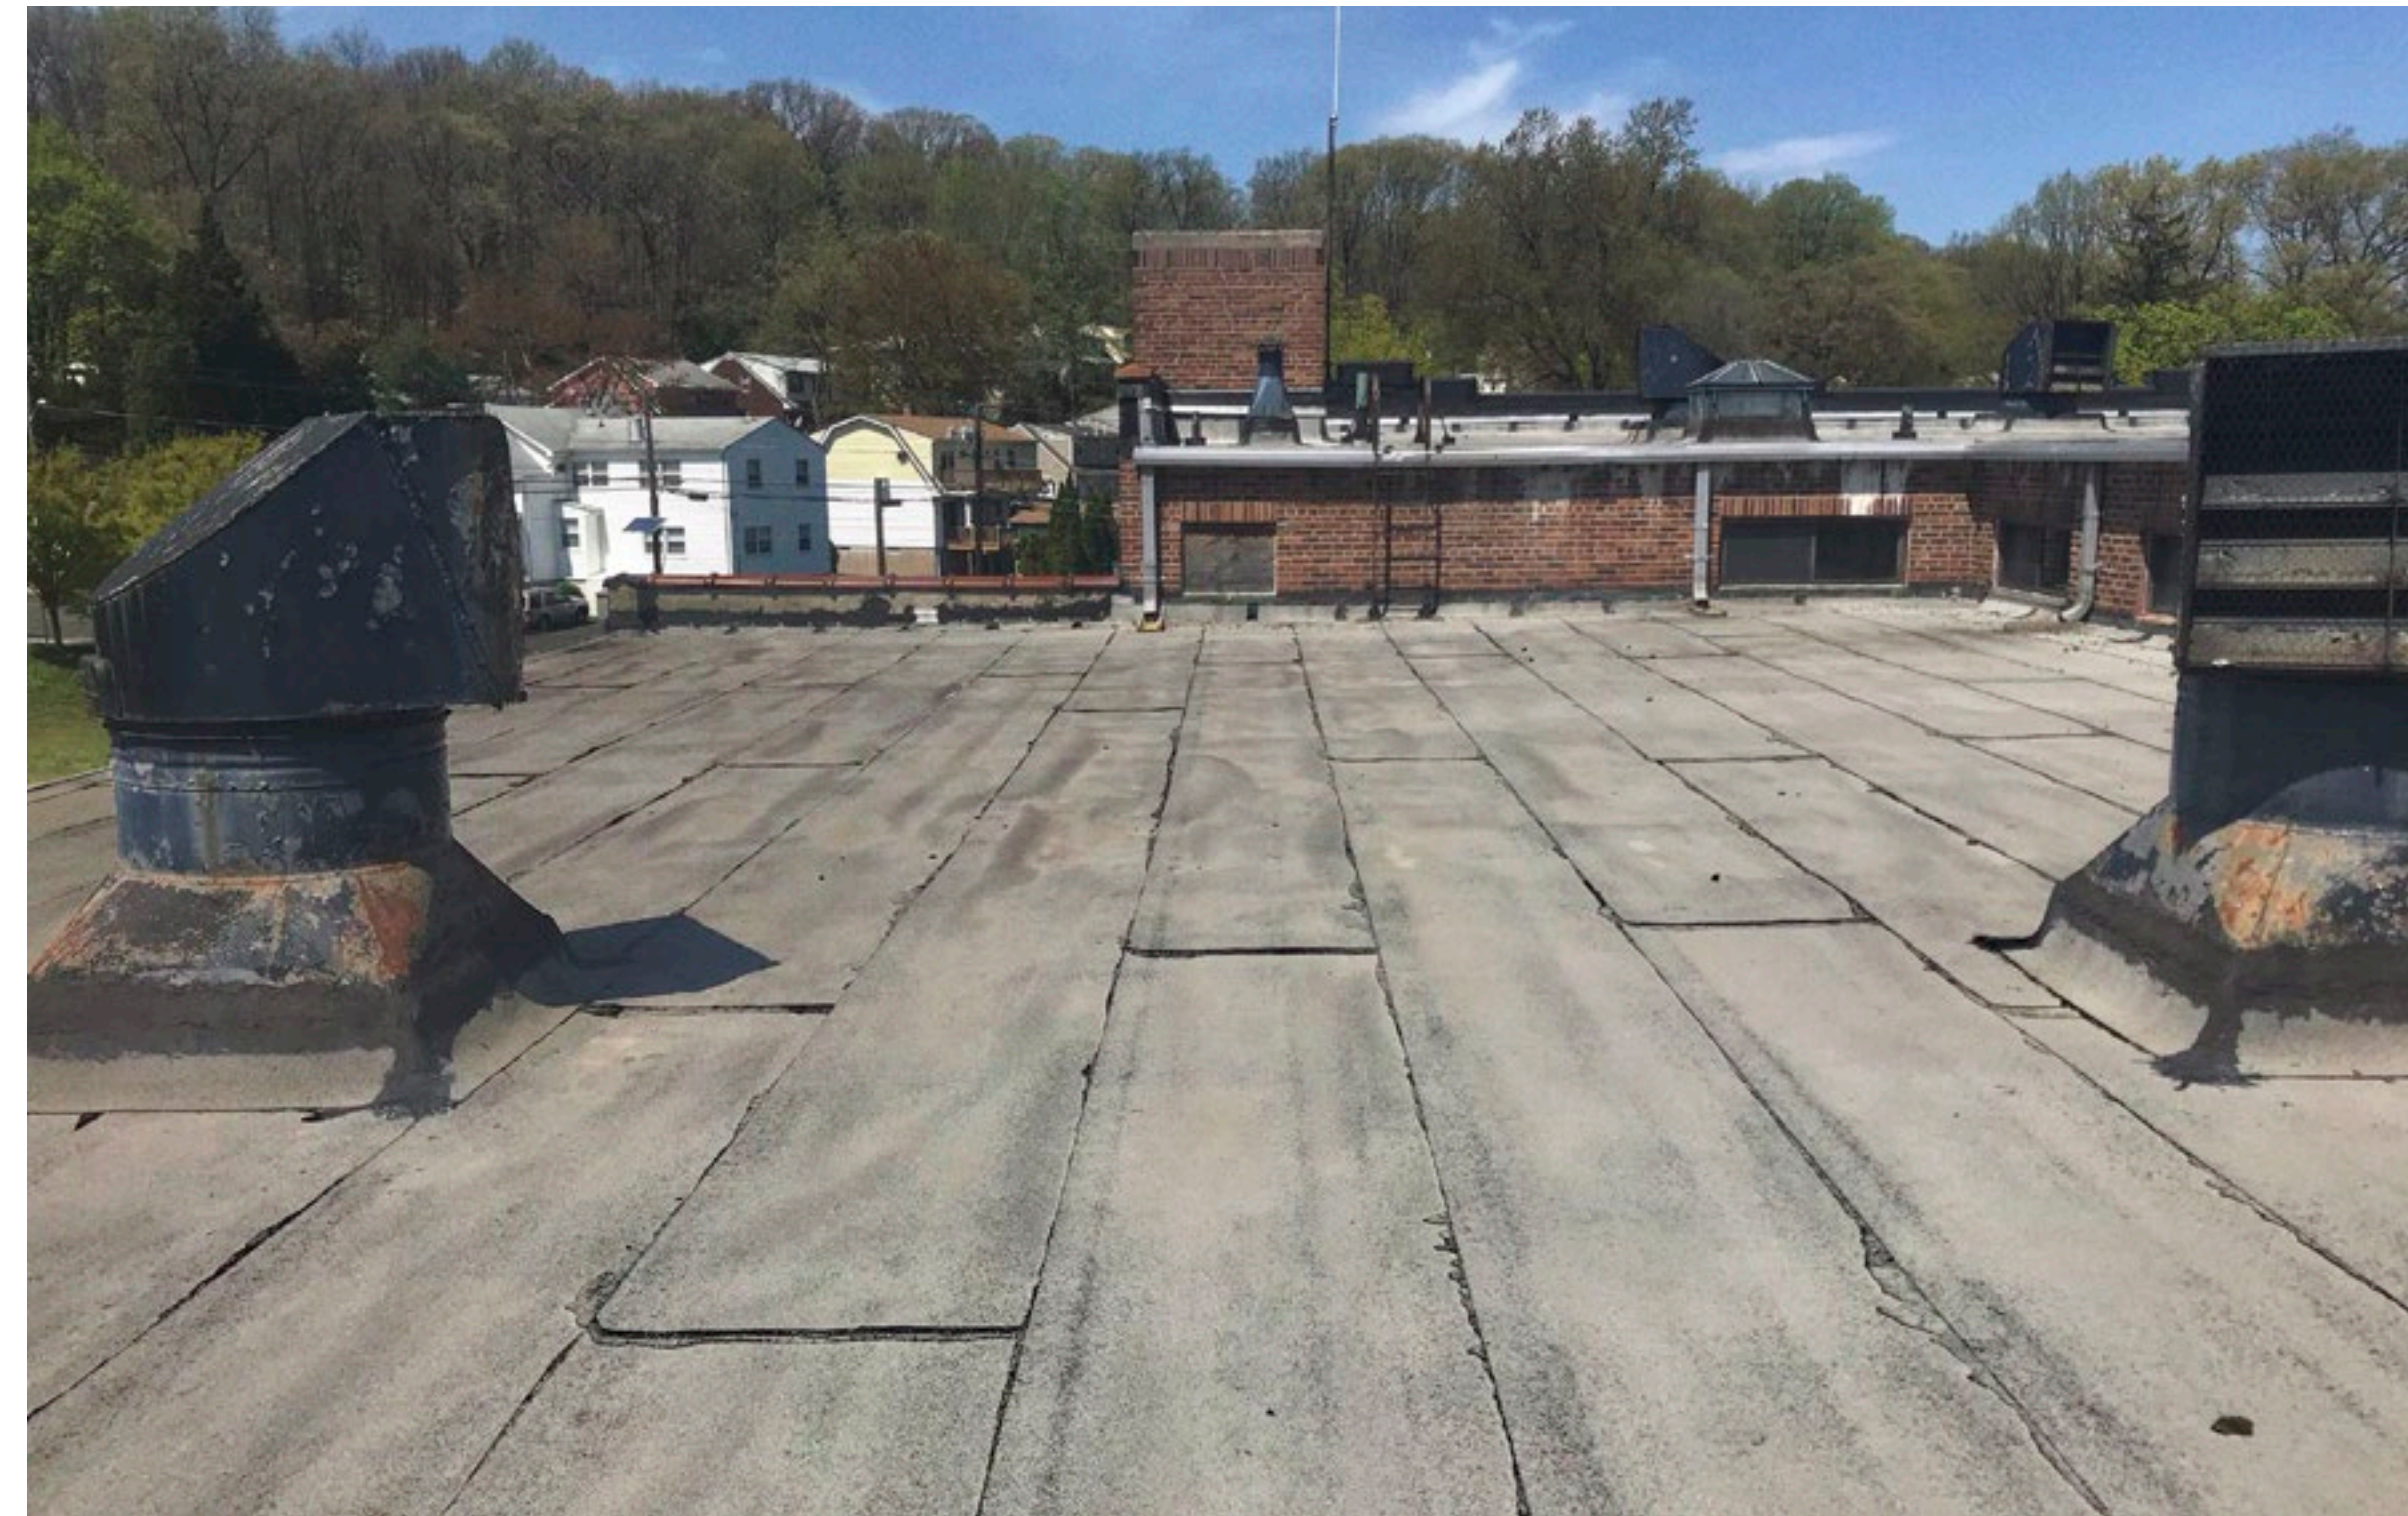
**AGED ROOF MEMBRANE IN POOR CONDITION**

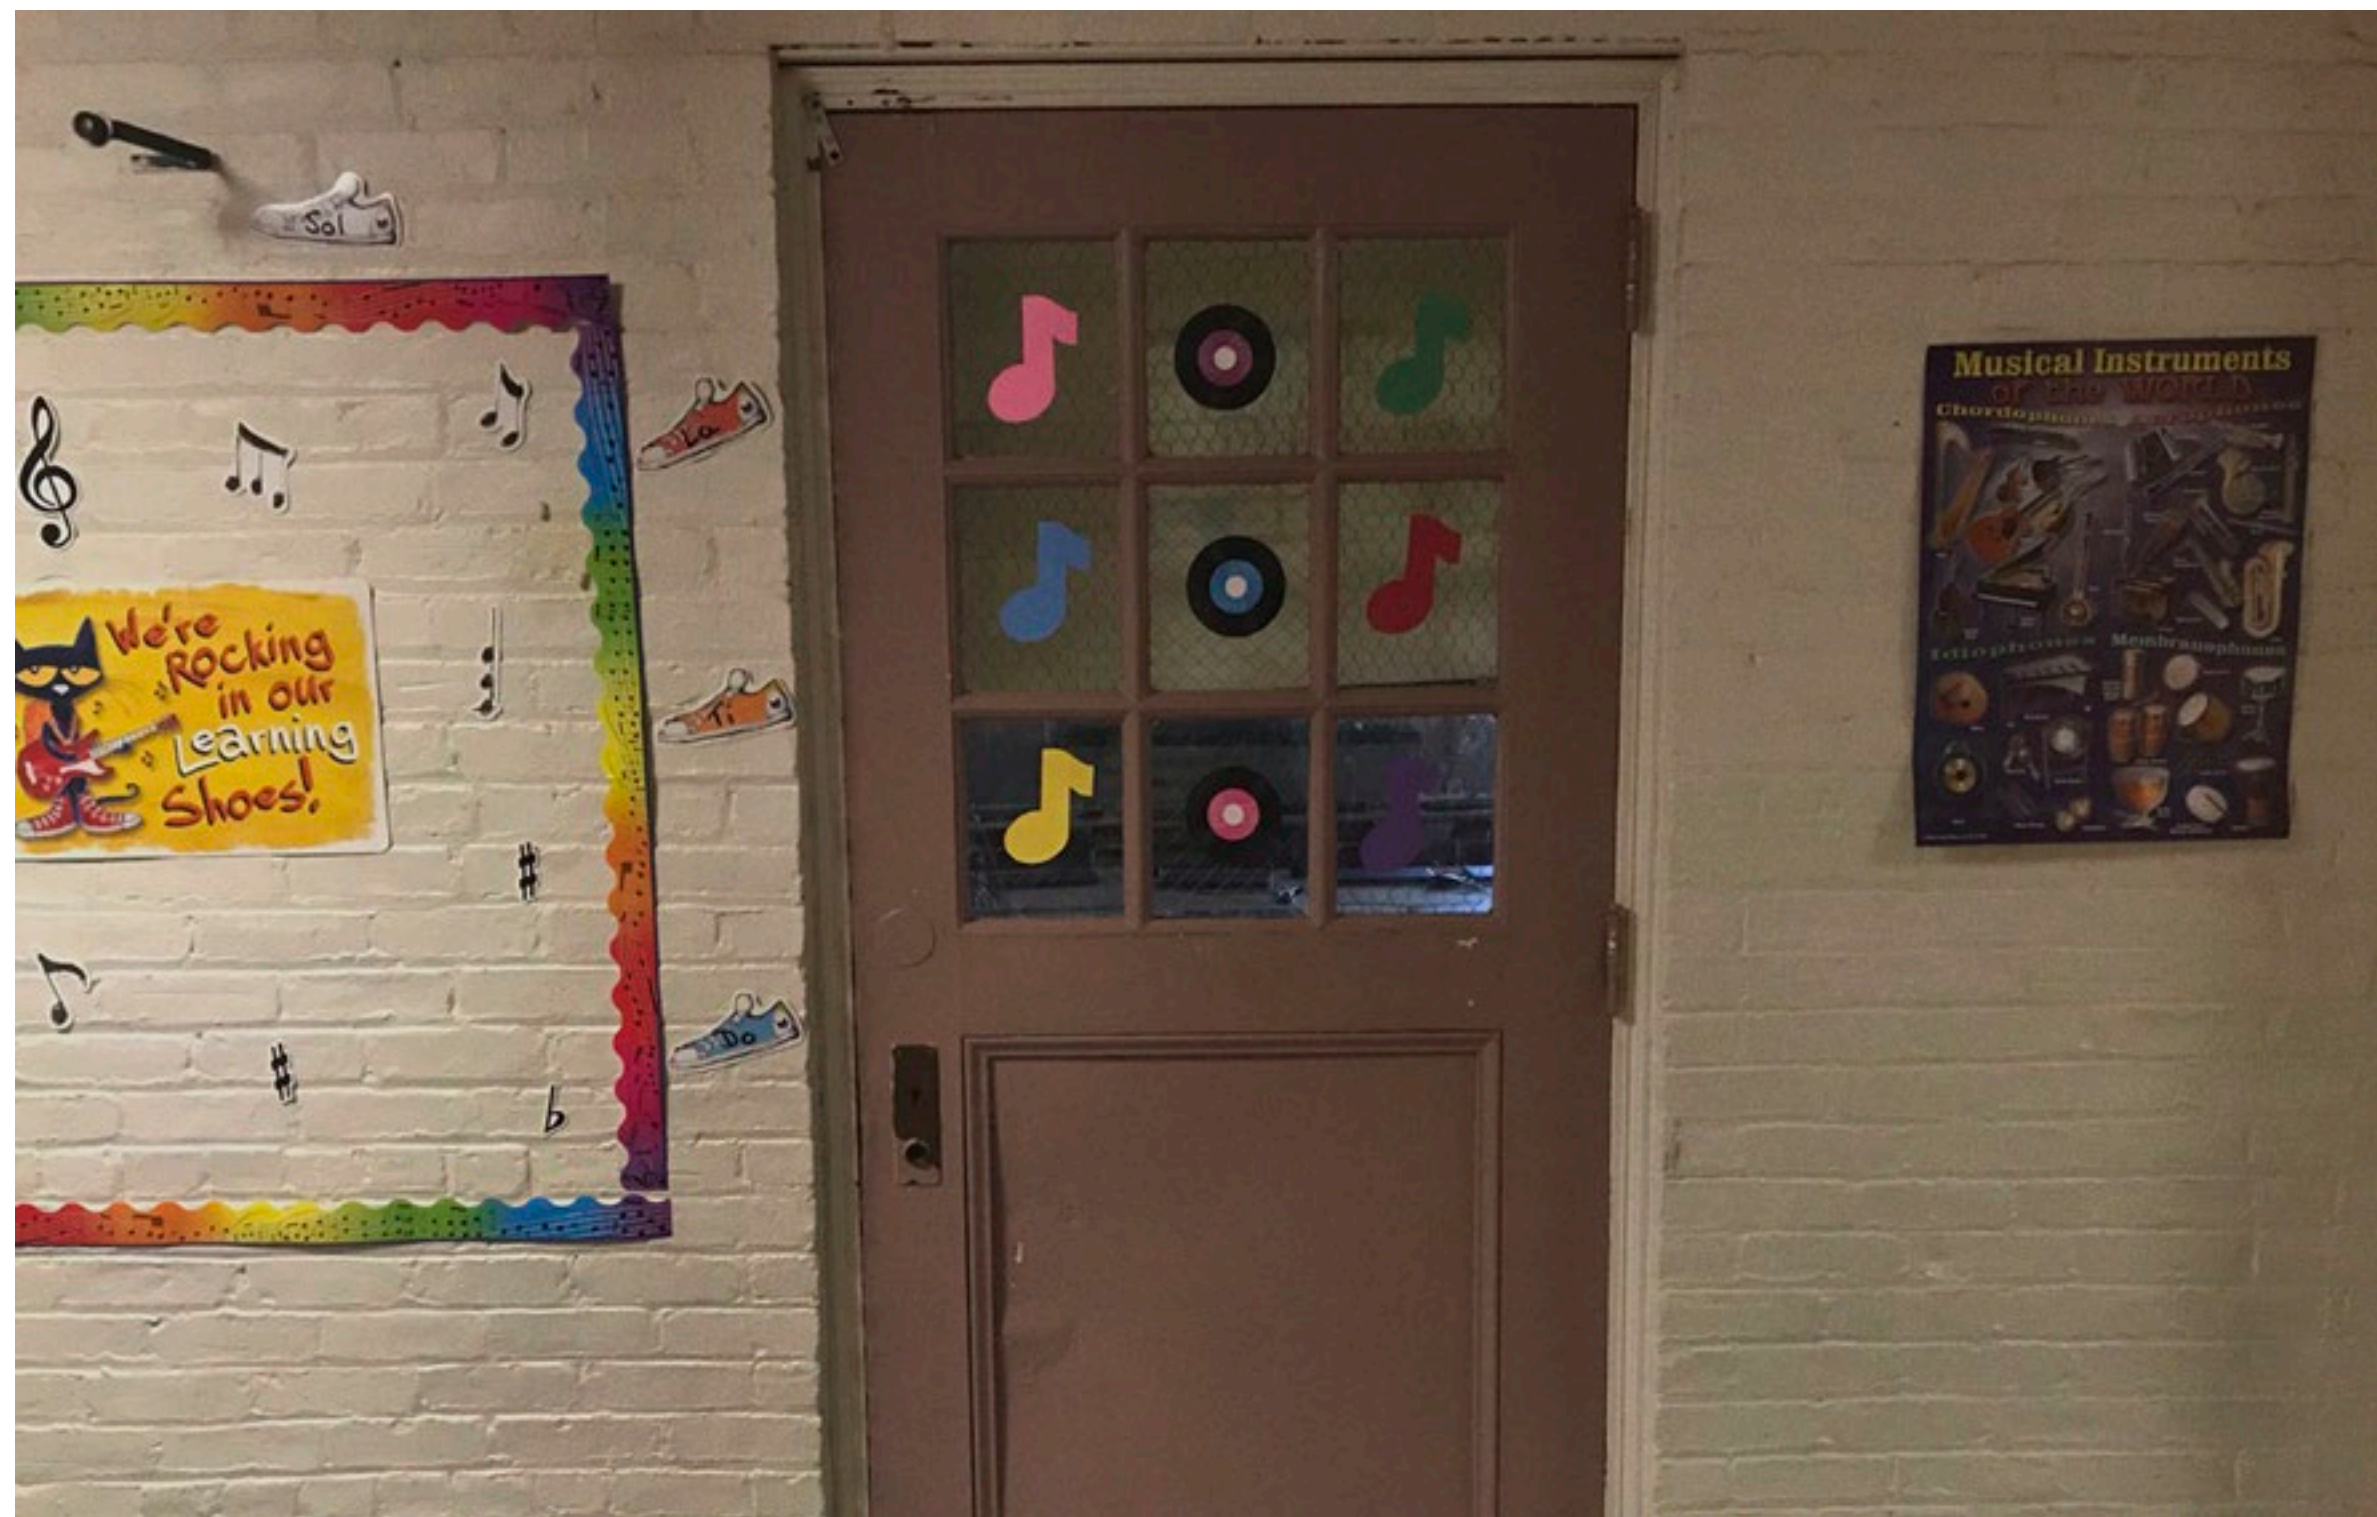
**GLASS PANELS ON DOOR CANNOT BE SECURED PROPERLY FOR LOCKDOWN**
